RE: Statement of Work; Protection and Restoration of the Blackjack Peninsula, Aransas National Wildlife Refuge (Contract #006)

<b>SITE VISIT REPORT</b>	CONTRACT NO./AQ PROJECT NO.	ES/Anchor QEA-1931 (4); 190737-01.01
		REPORT DATE/REPORT NO.	10/18/25; 1
		AQ FIELD REP.:	Nick Anderson
PROJECT NAME/LOCATION		Dagger Point Coastal and Marine Habitat Protection and Restoration/Austwell, TX

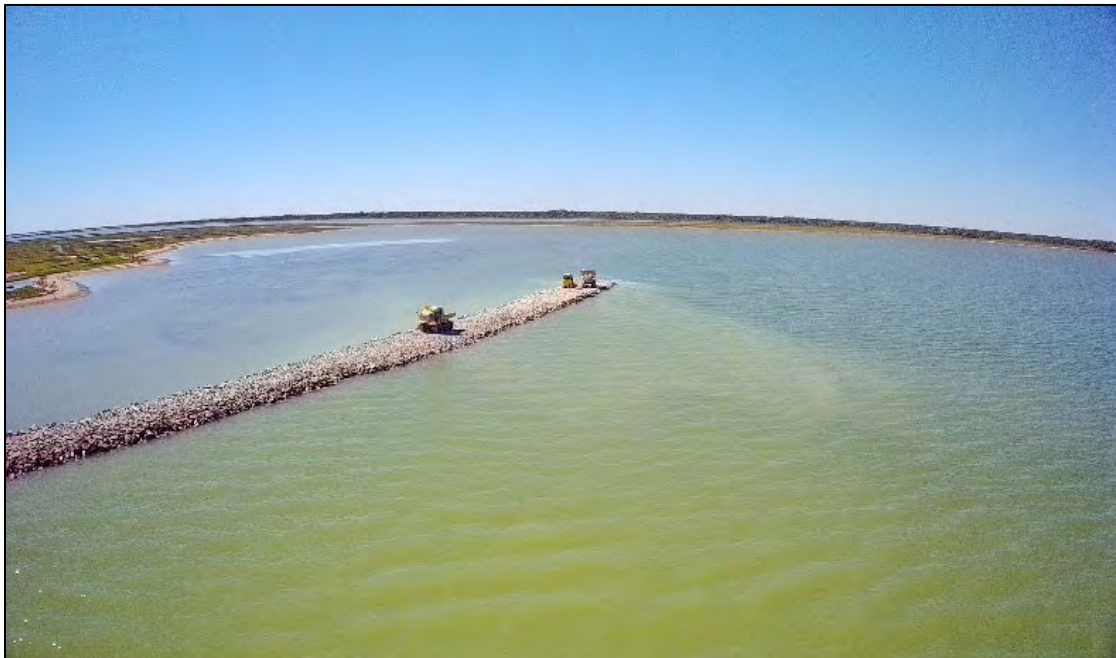
*Figure 1. Aerial view of breakwater construction along the eastern shoreline of Aransas National Wildlife Refuge on San Antonio Bay*

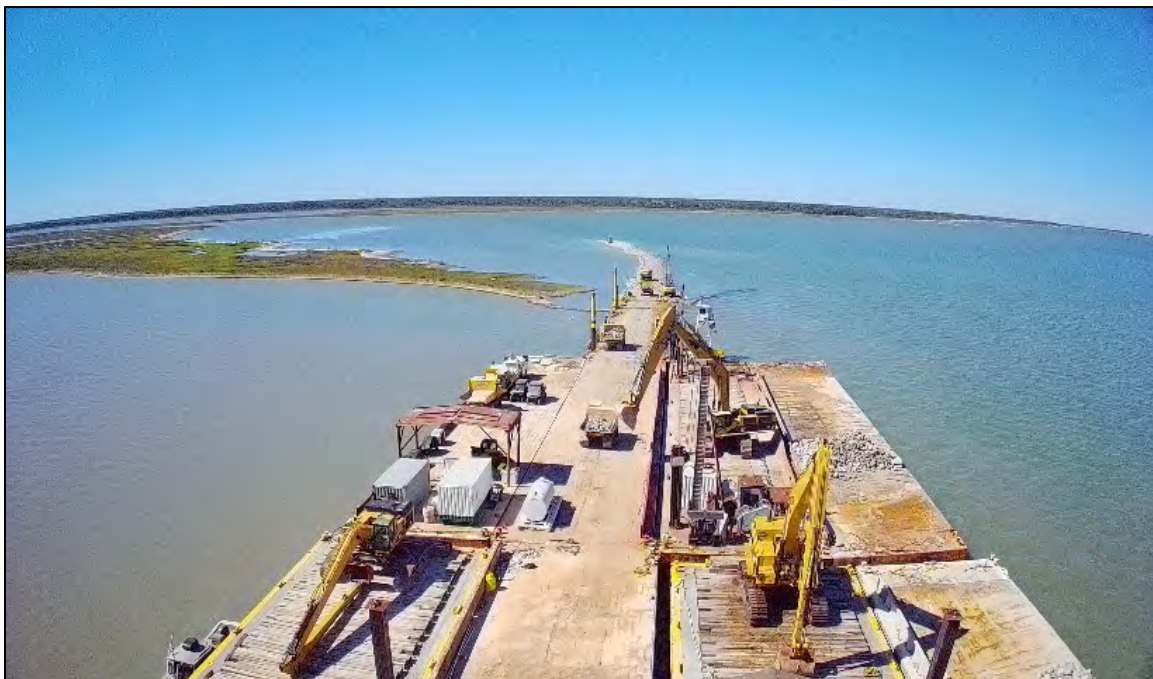
*Figure 2. Aerial view of staging area with ramp barge and equipment.*

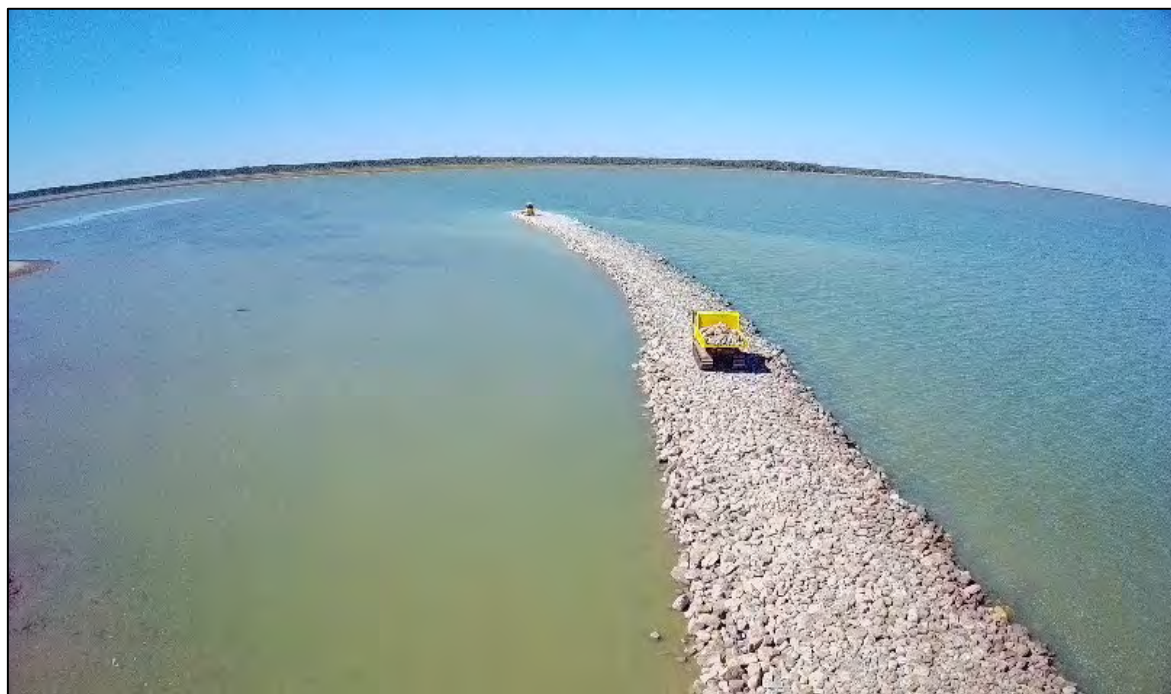
*Figure 3. Aerial view of breakwater construction.*

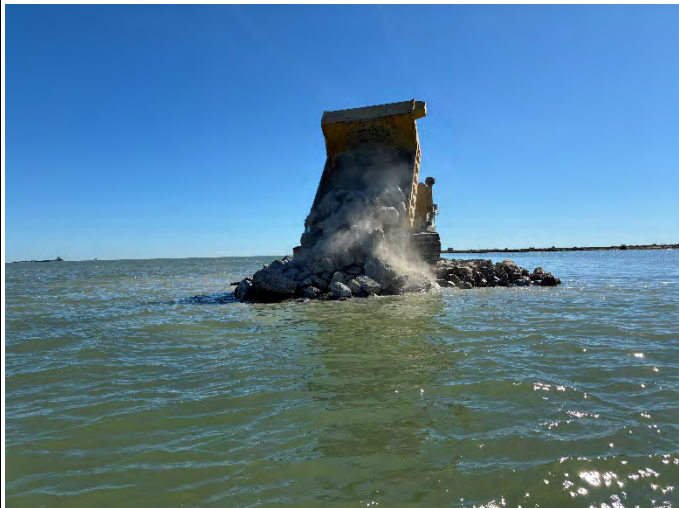
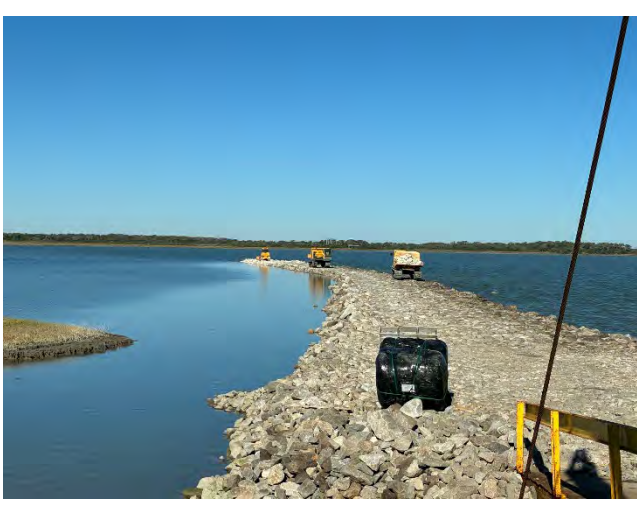
Comment:	Photo of rock placement along breakwater	Comment:	Photo representing overall progress of breakwater construction
