Activity report on the project “Microplastic concentration in sediments and waters of Matagorda and San Antonio Bays: Initial assessment and mitigation plans”

PIs: Cornel Olariu and Zhanfei Liu, The University of Texas at Austin

Period: July 1st, 2023, to December 30th, 2023 – Continuation of laboratory microplastics separation, opening of new cores, work on sediment grain size analysis, and initiation of total organic content (TOC) determination. Will Bailey presented some of the project results at the American Geophysical Union Conference in San Francisco.

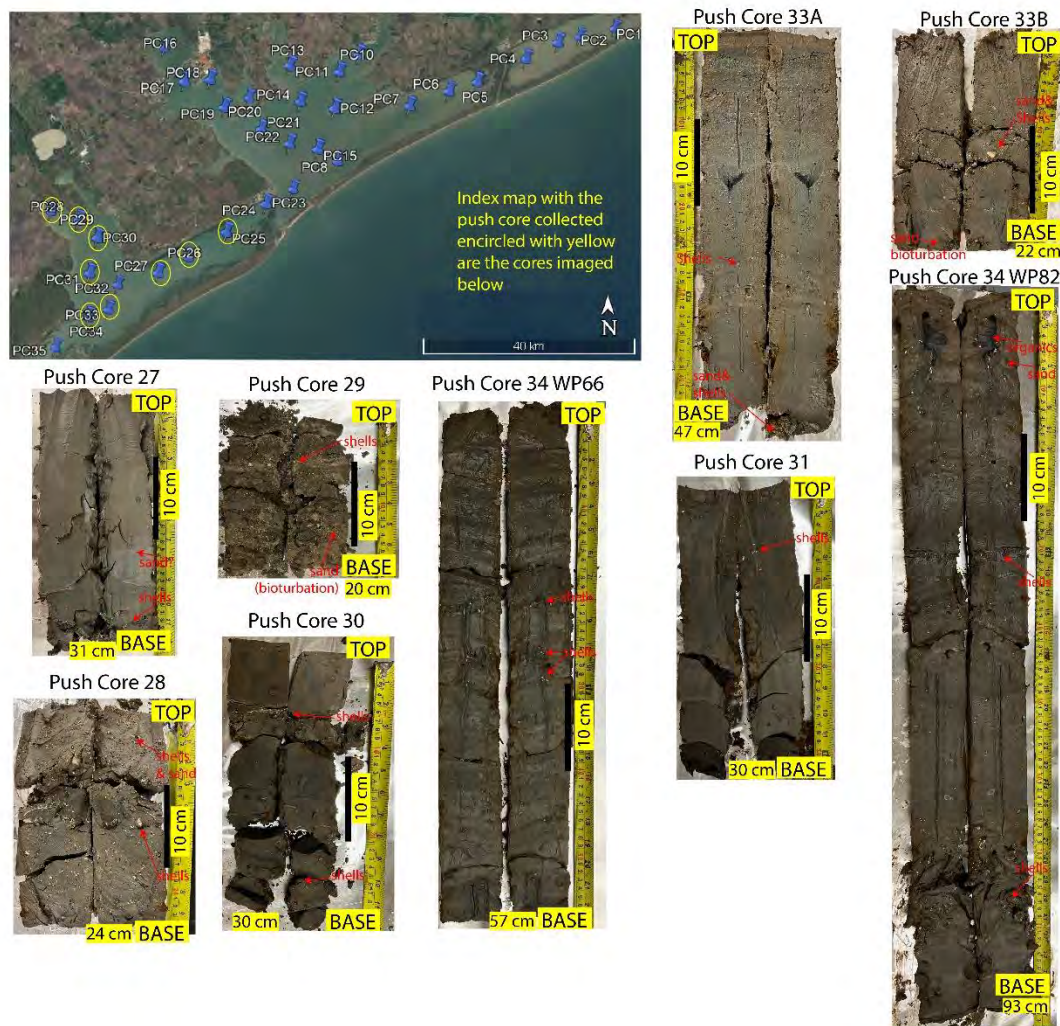
Figure 4. Photos of the sediment cores 27, 28, 29, 30, 34 WP66 and 34 WP82 from San Antonio Bay. Top left map indicates the location of the cores. Note that core 29 has multiple sand intercalations. Cores 30 and 34 WP82 have some clear shell fragments and (probably?) sand rich intervals indicating higher energy flow events.

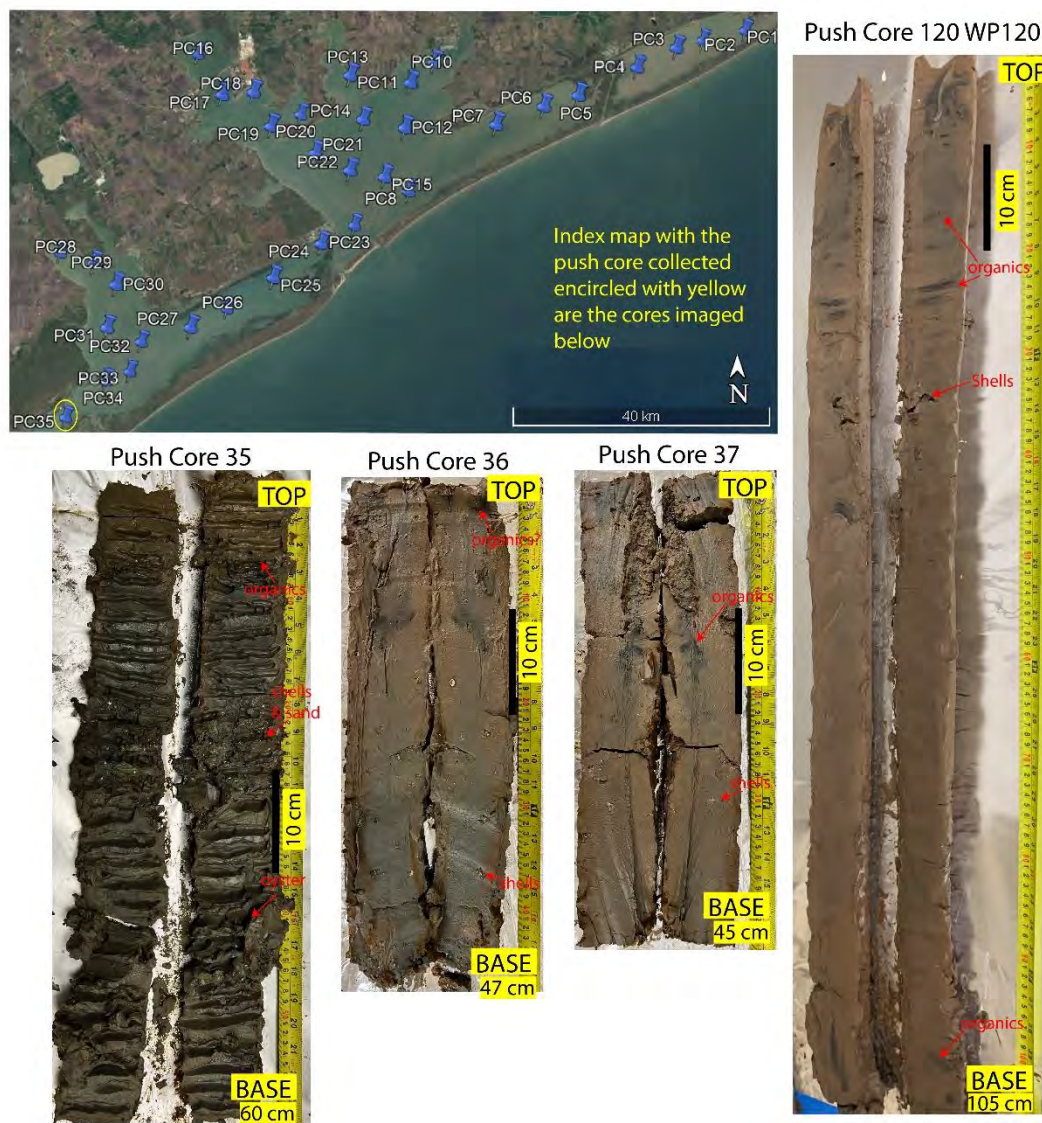
Figure 5. Photos of the sediment cores 35, 36, 37 (San Antonio Bay) and 120 (Matagorda Bay – Colorado river mouth). Top left map indicates the location of the cores. Cores are dominated by muddy sediments with varied degrees of brown to grey alteration. Core 120 (PC-5 location on the map) was collected at the mouth of the Colorado River, and is characterized by homogenous silt and clay indistinctly layered at the base, which transitions to finely laminated organic-rich beds near the top. These observations of A) massive or indistinct bedding may relate to regular mixing at the mouth of the river, and B) punctual (i.e., seasonal) drought and flooding events.

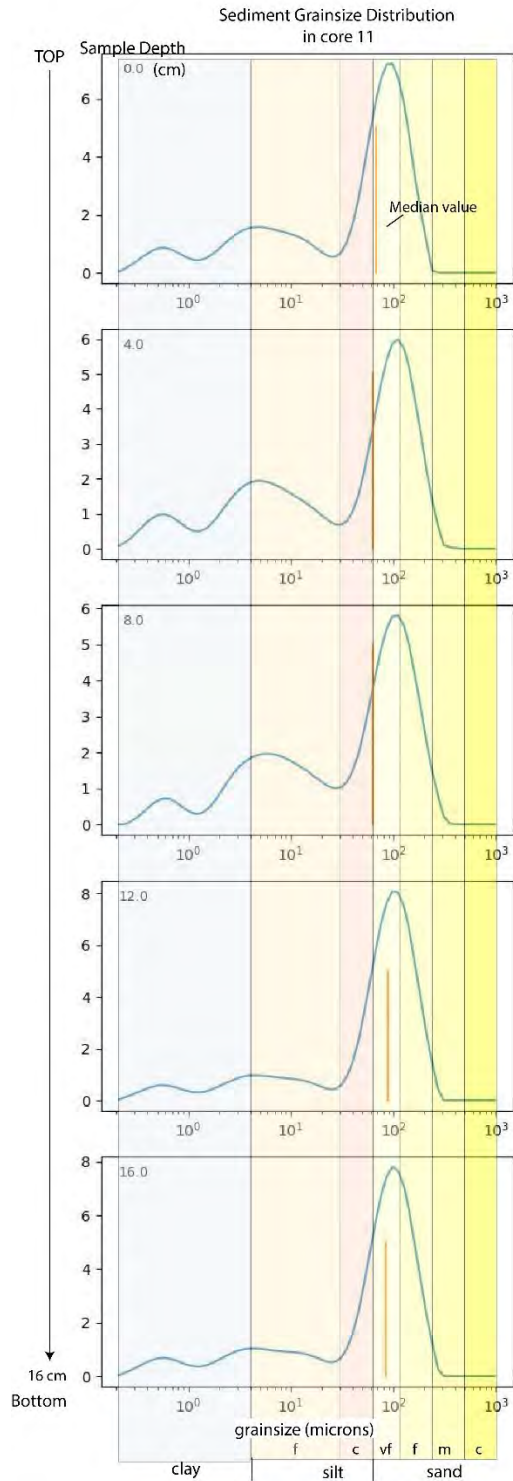
Figure 6. Sediment grain size in core 11. Multiple frequency histograms represent sediment samples at given depth in the core. On the X axis grainsize classes are separated and color coded to be easier to observe. The vertical orange line on each graph represents the median (d50) grain size value.

We will now discuss the new cores analyzed in addition to the 65 sediment grab samples already examined in previous reports. The grainsize results from cores were presented as histograms (grain-size class frequency) with depth (Figures 6 to 12). Sediment grain size is primarily dominated by silts (between 4 and 60 microns), but there are some notable observations related to grainsize variability. While silt is the dominant grain size, some sampled cores (e.g., core 11, Fig. 6) exhibited dominance by very fine and fine sand. Another interesting finding is the presence of multiple high-frequency "peaks" in different grain size classes in many samples. For instance, samples at the surface (0 cm) and at depths of 4 cm and 8 cm in core 13 (Fig. 7) displayed three grain size peaks in clay silt and very fine sands. Many other samples in different cores have bi-modal or tri-modal distributions. This observation suggests that sediments transported by different processes are mixed in the deposits, possibly due to bioturbation or anthropogenic factors.

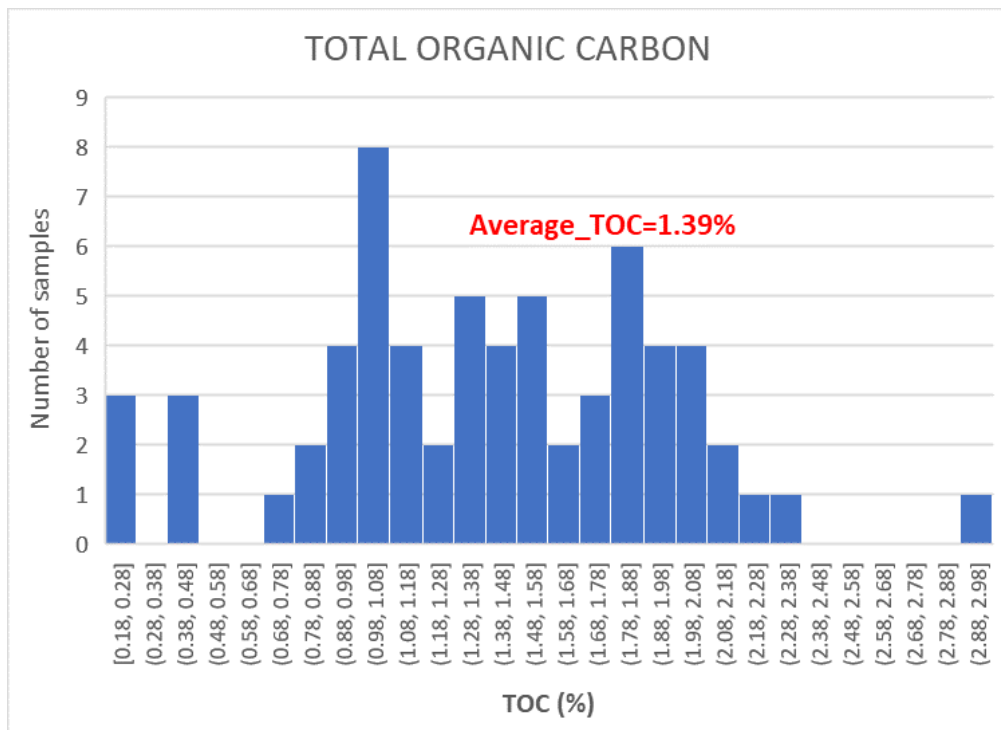
Figure 13 illustrates the distribution of Total Organic Carbon percentages in sediments at the bottom of the bay in grab samples and at the top of cores. The average TOC value is 1.39%.

The distribution of Total Organic Carbon (TOC) in Matagorda Bay was analyzed for all grab samples and for some of the cores. Understanding the association of organic carbon with microplastics is crucial, as organic material can serve as food for many organisms, and the presence or association of microplastics may harm fauna. To date, 65 grab samples from Matagorda Bay and the tops of cores have been analyzed for TOC content (see Table 1). Additionally, cores 11, 13, 21, 31, 35, 36, and 37 have also been analyzed for TOC. The overall variability in TOC values ranges from 0.2% to 3%, with most values falling between 0.8% and 2.2% TOC (refer to Fig. 13). These values are higher than the TOC values reported in McGowan’s (1979) study, where most samples contained less than 0.5% TOC. This difference might be explained by increased of organic material accumulation in the bay caused by increased restricted circulation with the ocean. However, as previously mentioned, it also may be attributed to the different laboratory methods used, specifically Loss on Ignition in this study versus Wet Combustion in McGowan (1979) study.

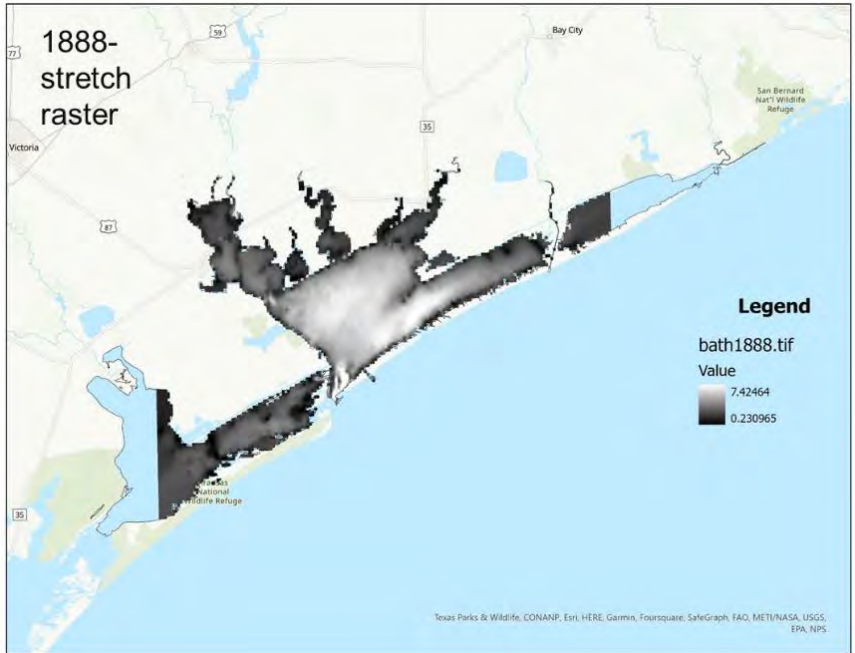
Figure 15. Digized and re-gridded navigational bathymetric chart from 1888, depth units in meters.

Sediment accumulation from bathymetry maps was also examined to better understand sediment dynamics in Matagorda Bay. Historical nautical charts from 1888, 1934, 1954, 1970, and 1981 (see Fig. 14) were digitized using ArcGIS software and re-gridded (see Fig. 15). Historical water depth values were subtracted between the different digital gridded maps and the modern NOAA depth soundings to quantify temporal changes and highlight the bay fill evolution.

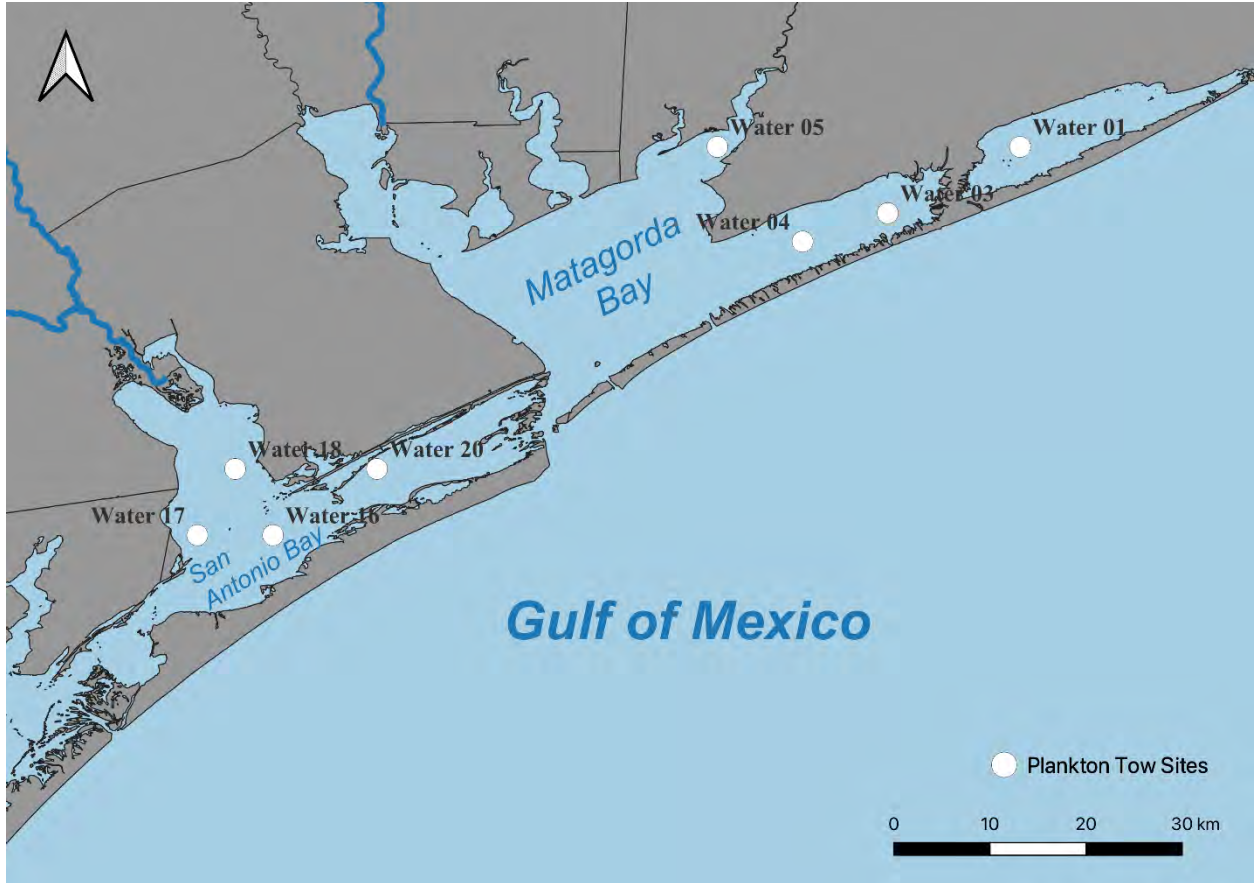
Figure 17. Sampling locations of surface water of Matagorda Bay and San Antonio Bay 2023.

Fieldwork conducted in September 2023 was centered on examining plastics in the surface water of Matagorda Bay. Utilizing a plankton net (see Figure 17), we collected surface water samples at eight offshore stations within the Matagorda and San Antonio bays. Currently, we are still processing these water samples, including digestion and subsequent analysis via Pyrolysis GC/MS. The forthcoming report will detail the occurrence, abundance, and distribution of microplastics within the surface water of Matagorda Bay during the 2023 study period.

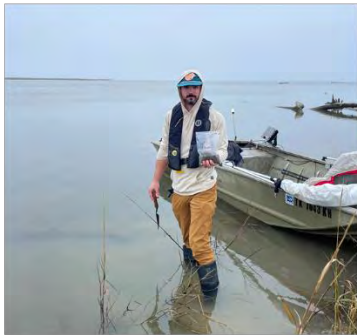
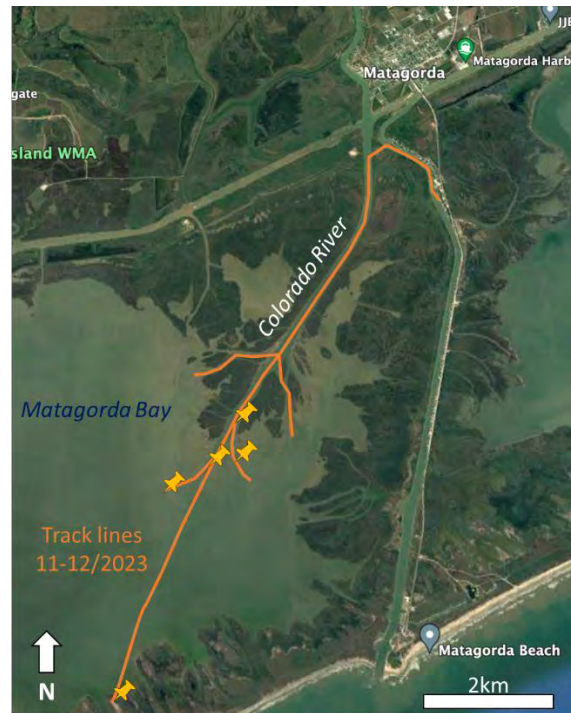
Figure 18. Data collected during December 2023 field work. Lower left photo show sediment data collected in delta front area of Colorado. On the right the lines of Chirp data and sediment sample locations.

Fieldwork conducted in December 2023 focused on the Colorado River Delta and adjacent area, located in the eastern part of Matagorda Bay. The Colorado River might be a source of microplastics because its catchment contains large urban areas. During this week-long campaign, sidescan and CHIRP data were collected to enhance our understanding of bathymetry and sedimentation in the Colorado Delta. Additionally, sediment grab samples were obtained to analyze the microplastic content of river-derived sediments accumulating in the bay (see Figs. 18 and 19).

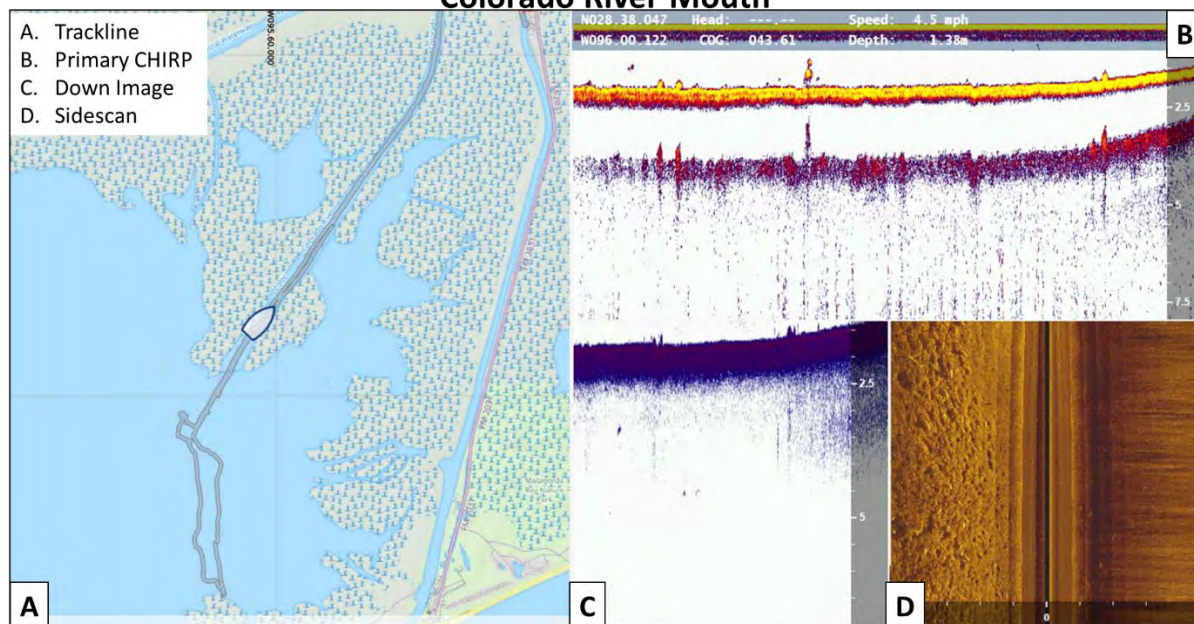
Figure 19. Example of CHIRP and Sidescan data collected along the Colorado Delta distributary channel.
