Schicke Point Living Shoreline

Response to Matagorda Bay Mitigation Trust
RFP# 2020-2021-1

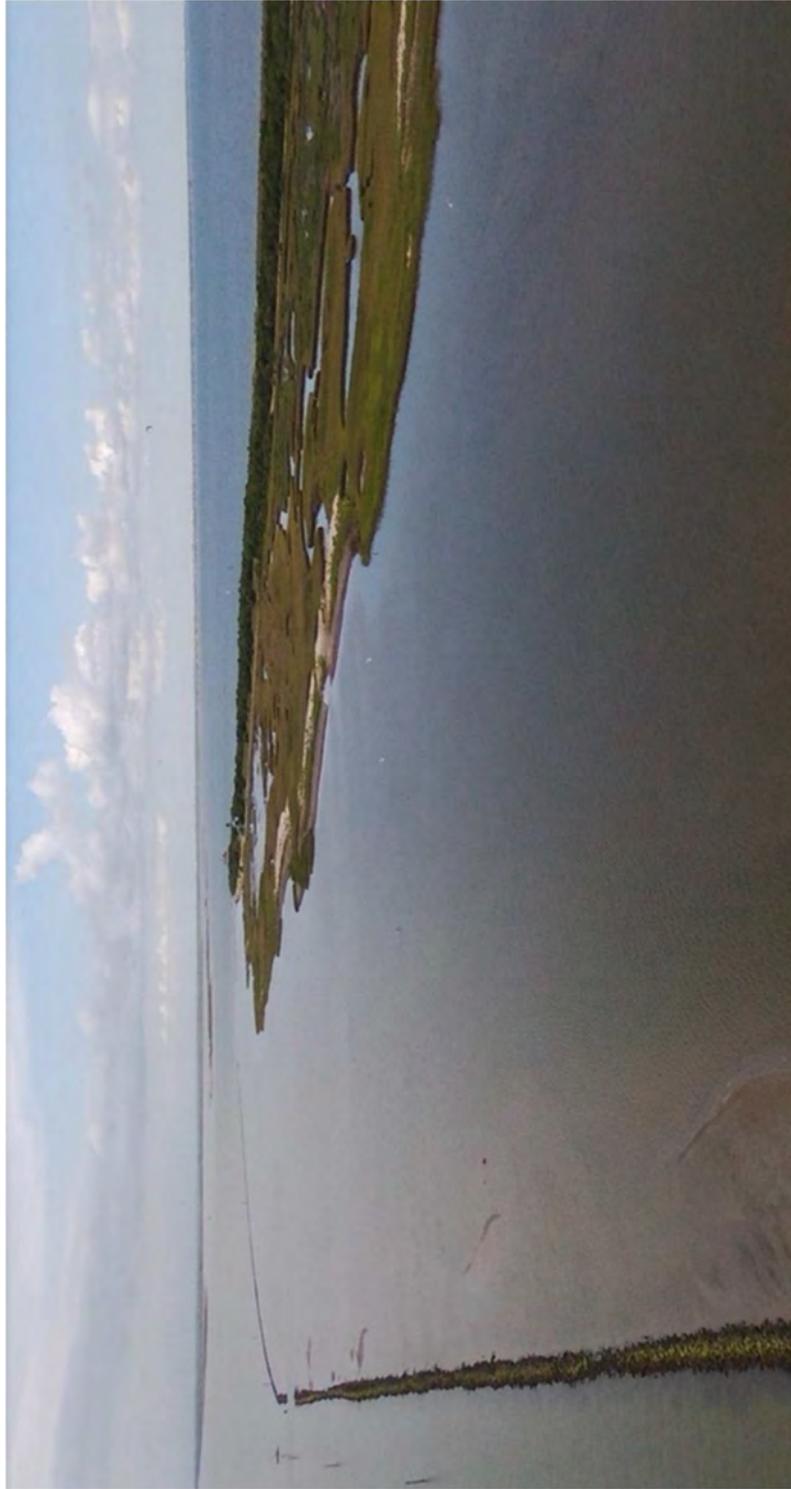
Figure 2. Schicke Point living shoreline constructed in May 2017 showing bands of sediment accumulation and Smooth Cordgrass/oyster marsh complex behind the living shoreline (July 6, 2018). Coastal forest visible in the background.

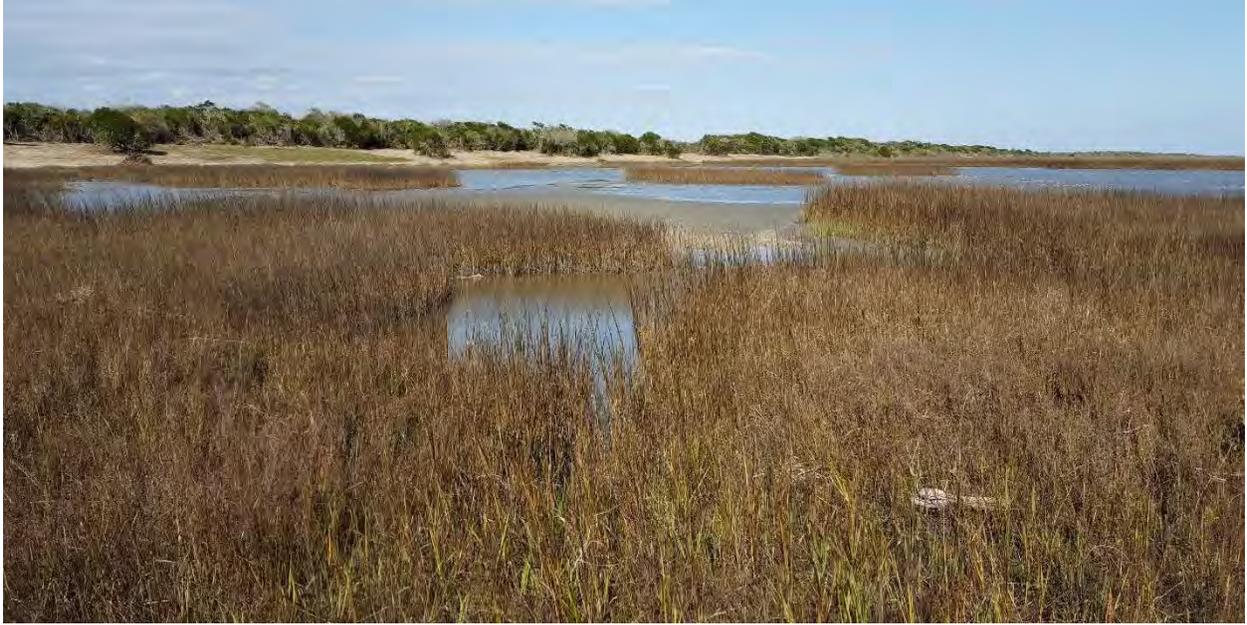
Figure 3. Schicke Point estuarine emergent marsh (persistent and regularly flooded) (February 5, 2016).

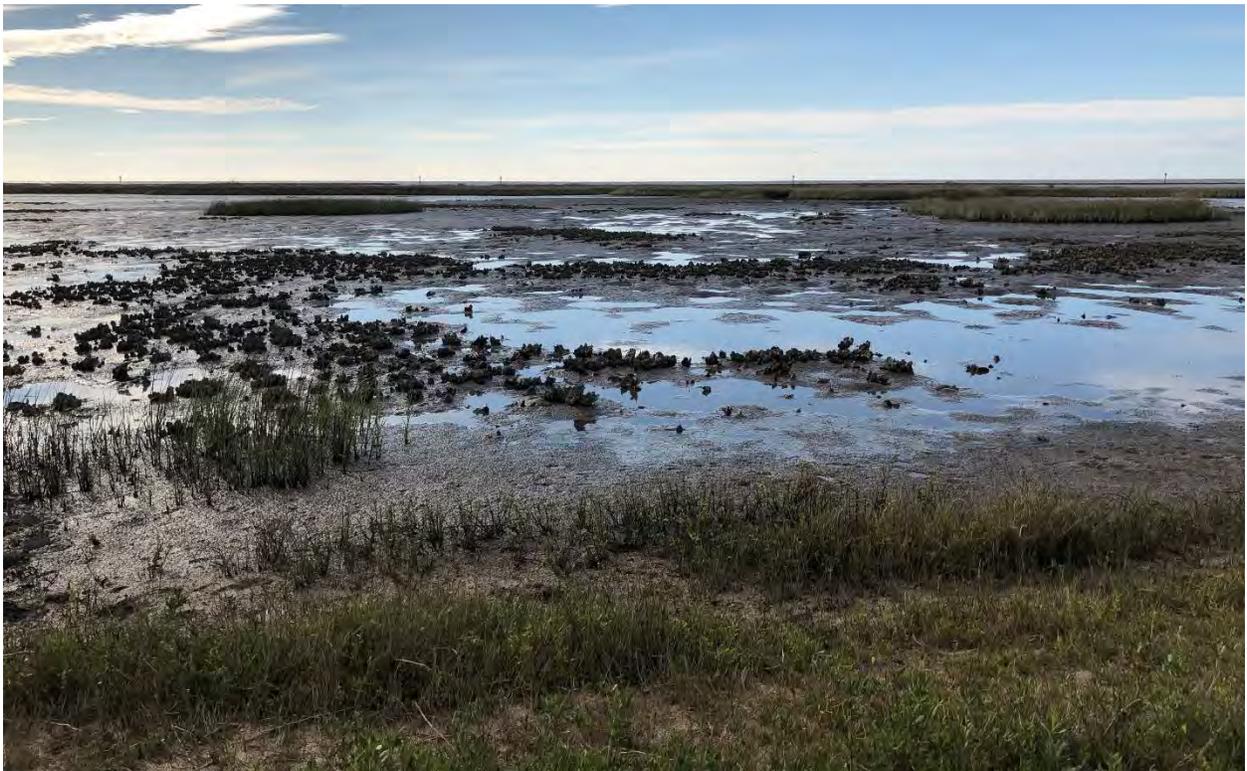
Figure 4. Schicke Point estuarine emergent marsh (persistent and regularly flooded) (March 5, 2019).

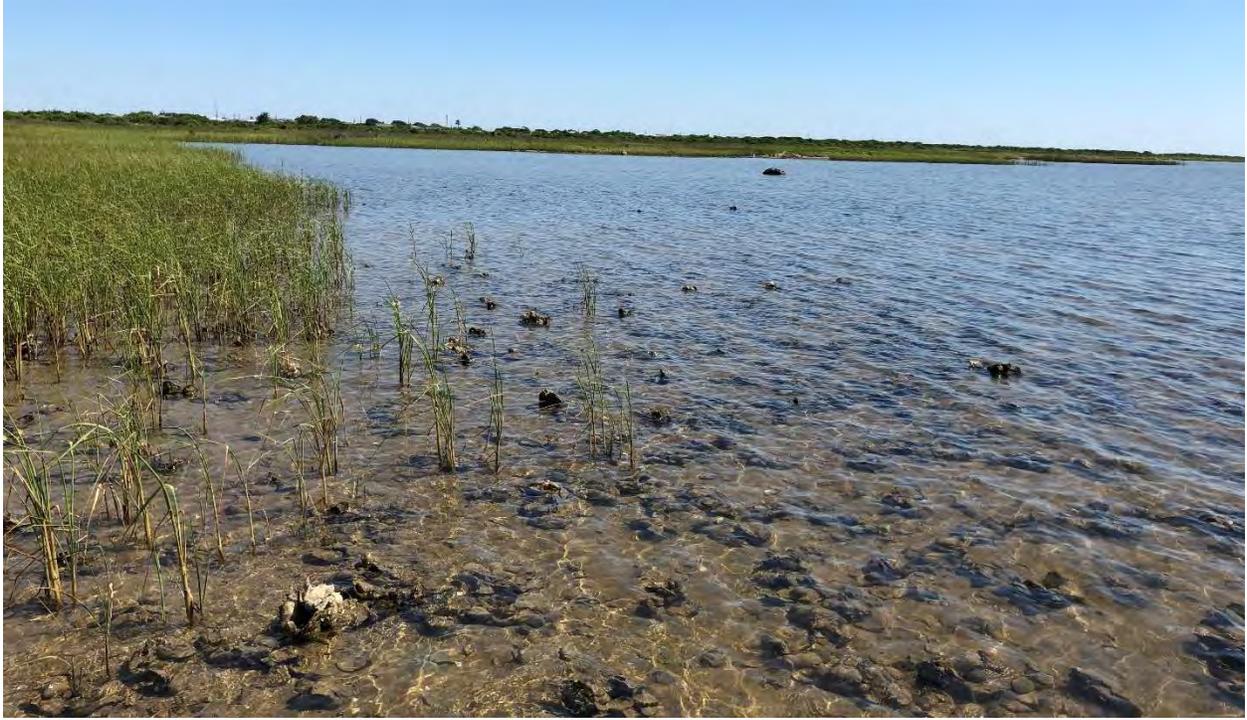
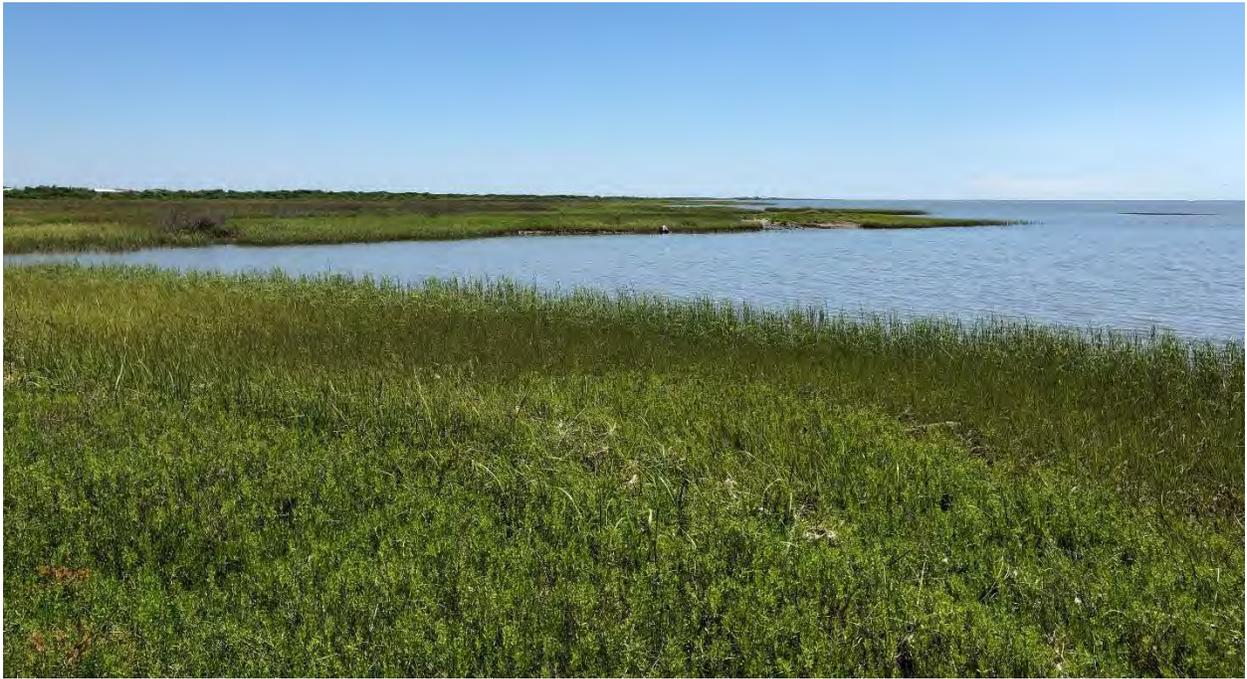
Figure 5. Schicke Point estuarine emergent marsh (persistent and regularly flooded) (April 29, 2019).

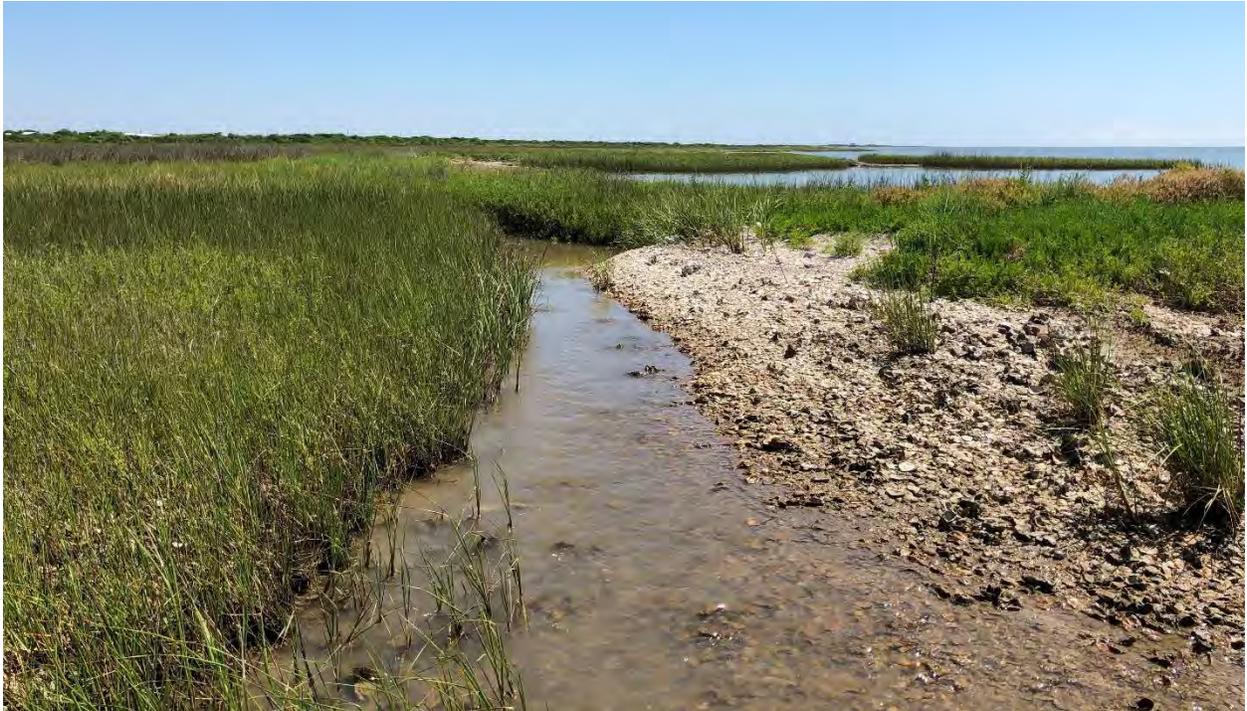
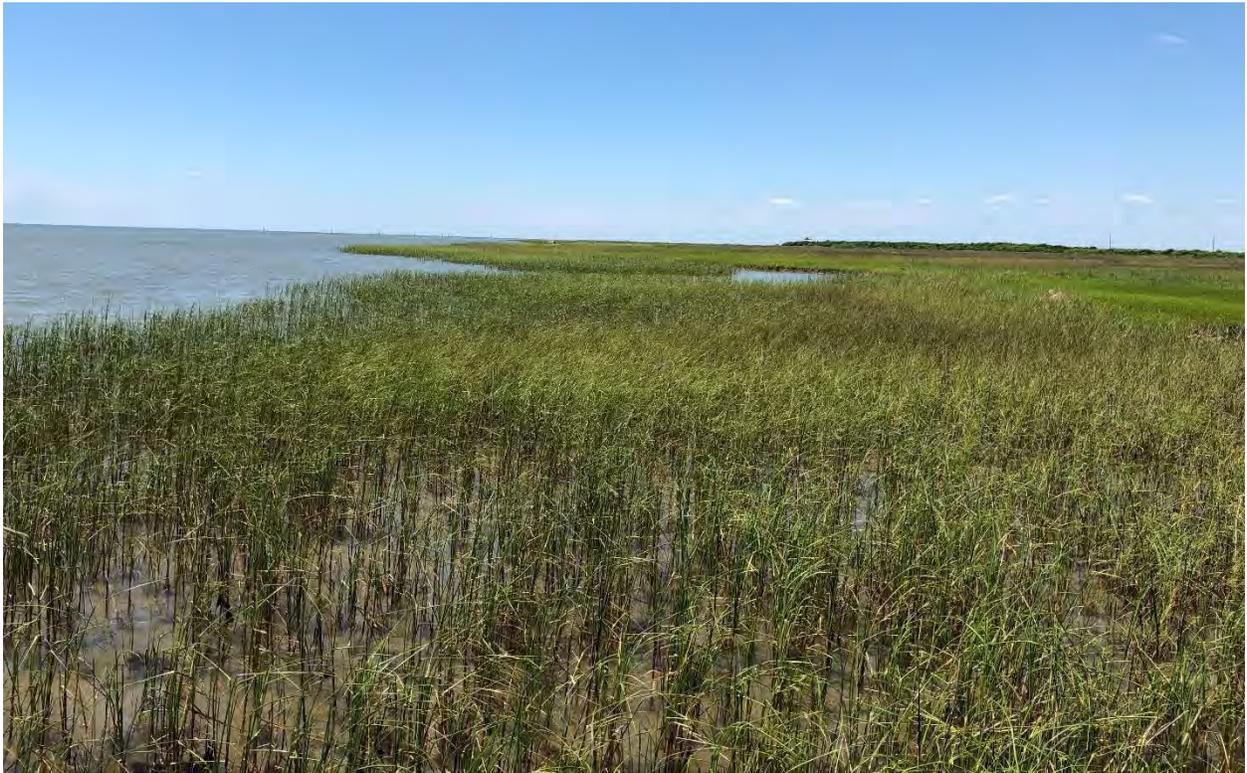
Figure 6. Schicke Point estuarine emergent marsh (persistent and regularly flooded) (April 29, 2019).

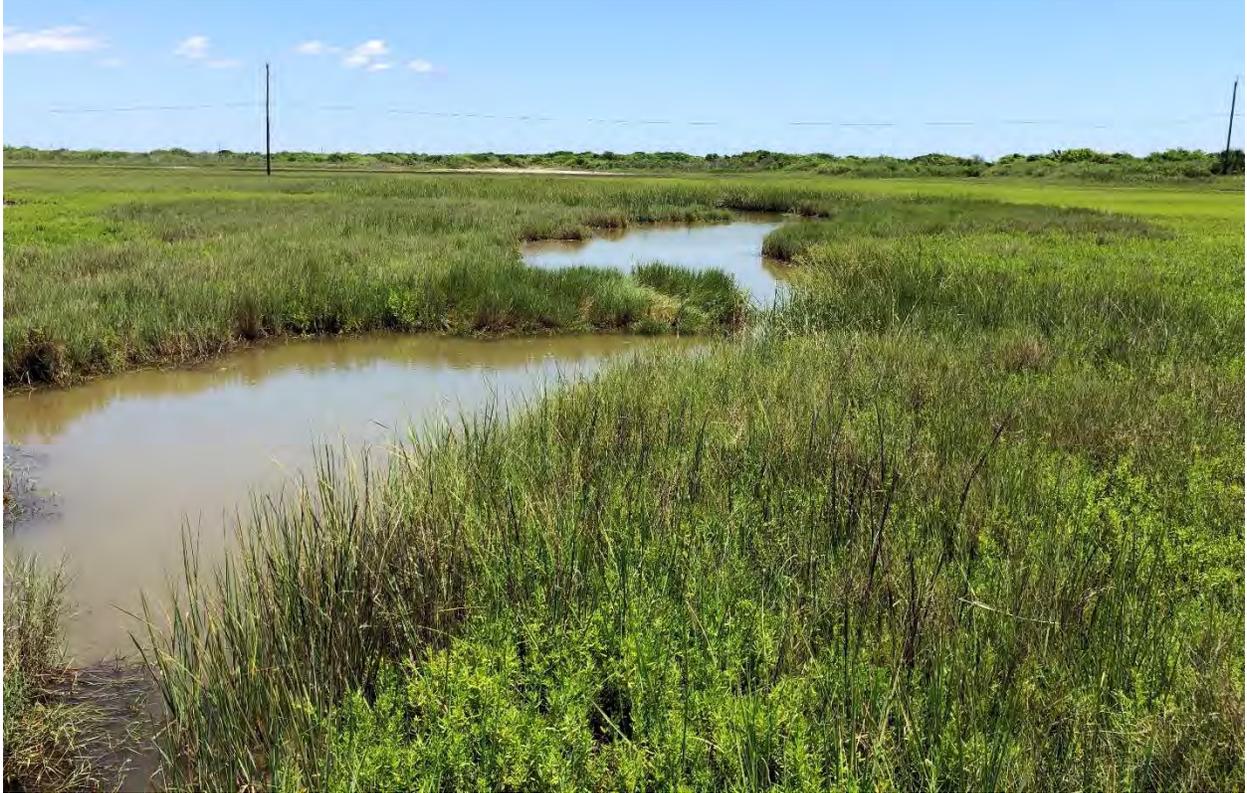
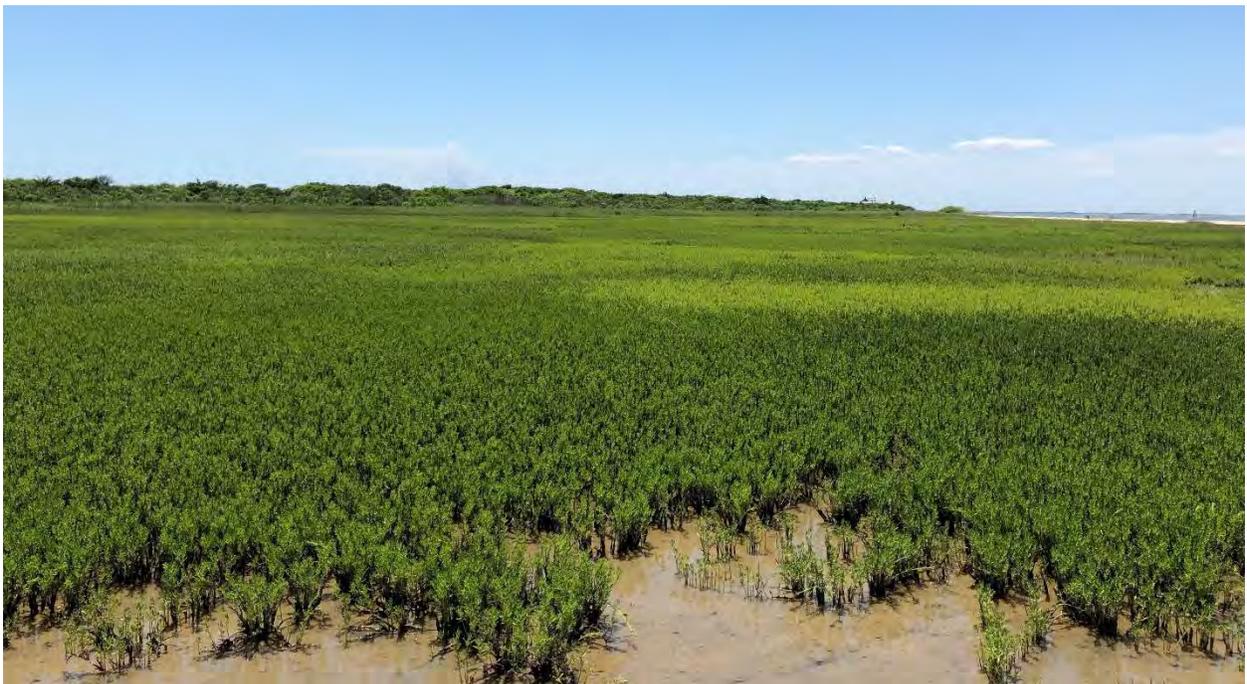
Figure 7. Schicke Point estuarine emergent marsh along the Carancahua Bay shore (persistent and irregularly flooded) (April 29, 2019).

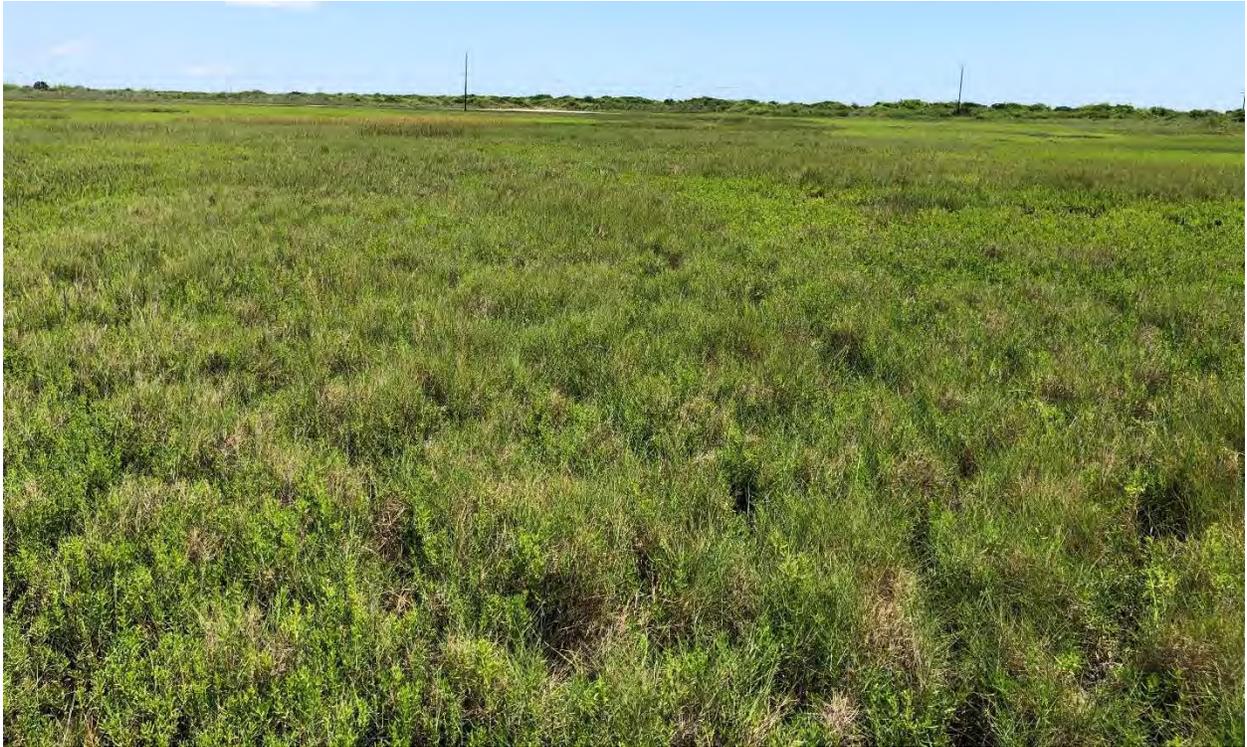
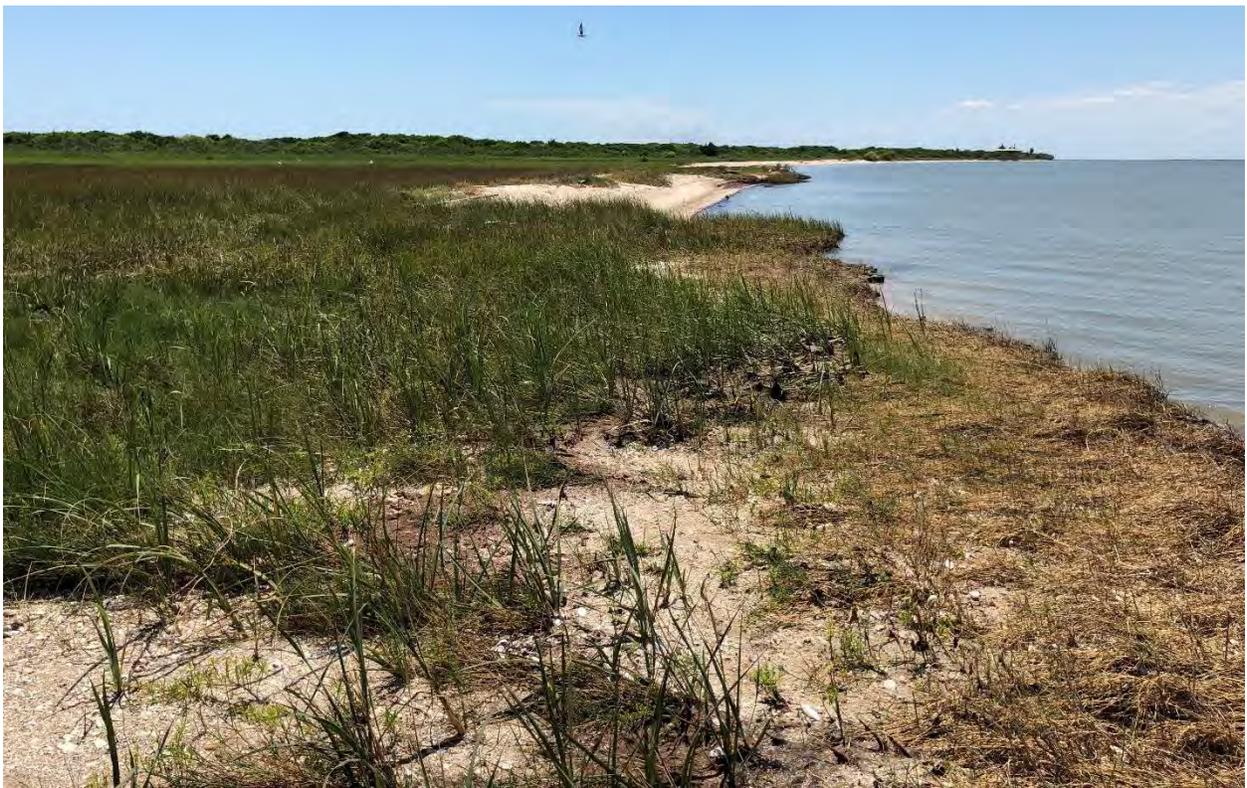
Figure 8. Schicke Point estuarine emergent marsh along the Carancahua Bay shore (persistent and irregularly flooded (April 29, 2019)).

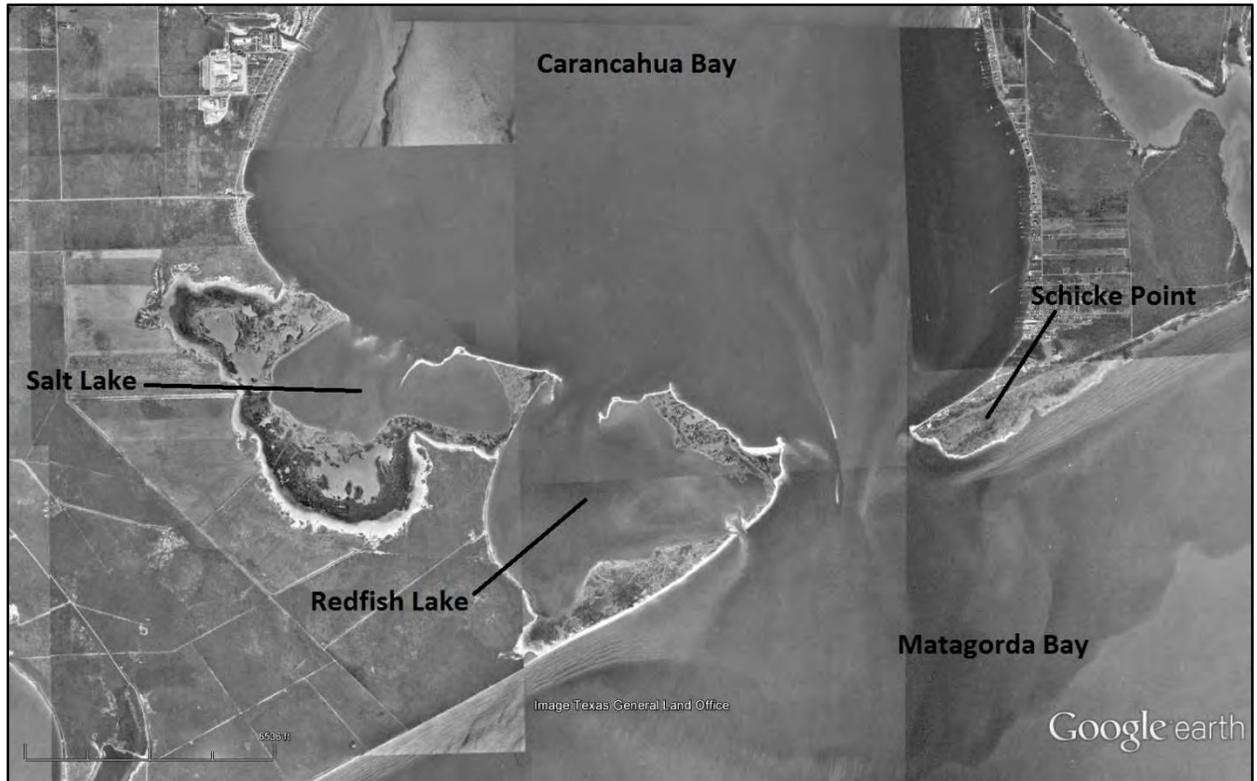
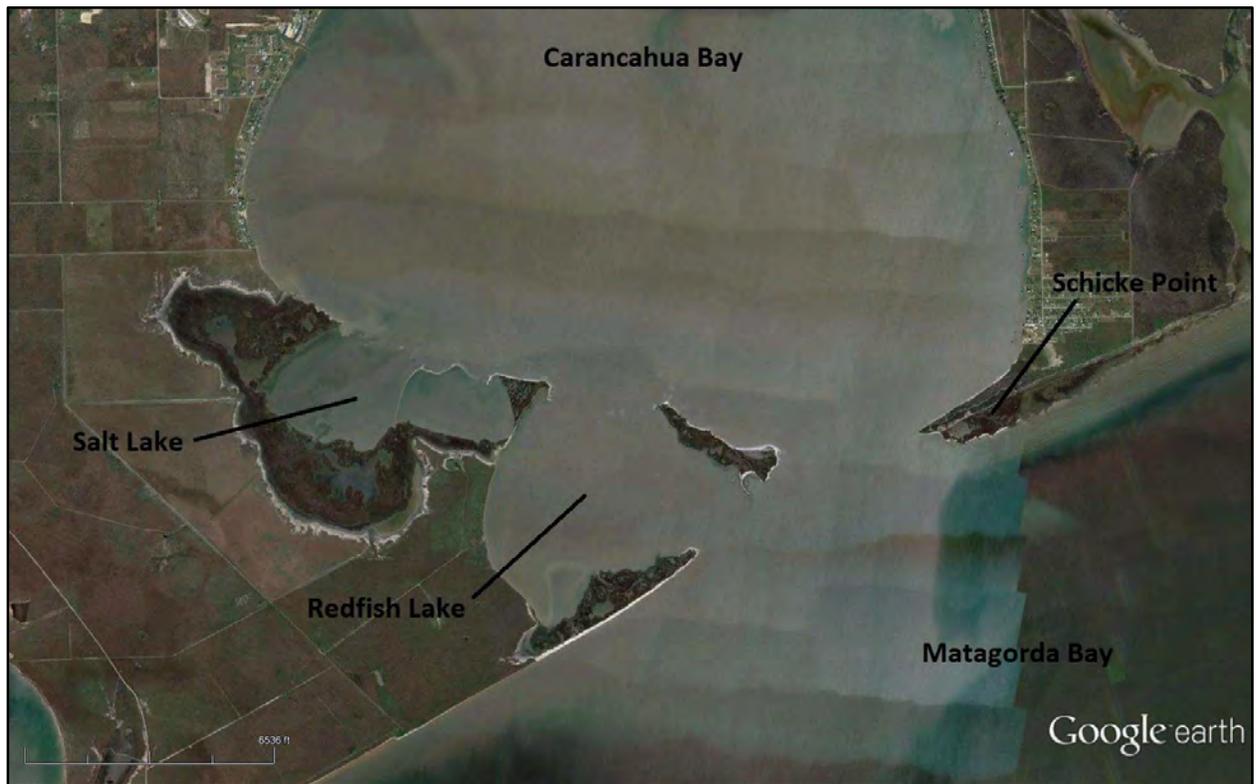
Figure 10. Erosion and marsh loss at mouth of Carancahua Bay, including Schicke Point (upper photograph taken December 31, 1989 and lower photograph taken February 2, 2016).

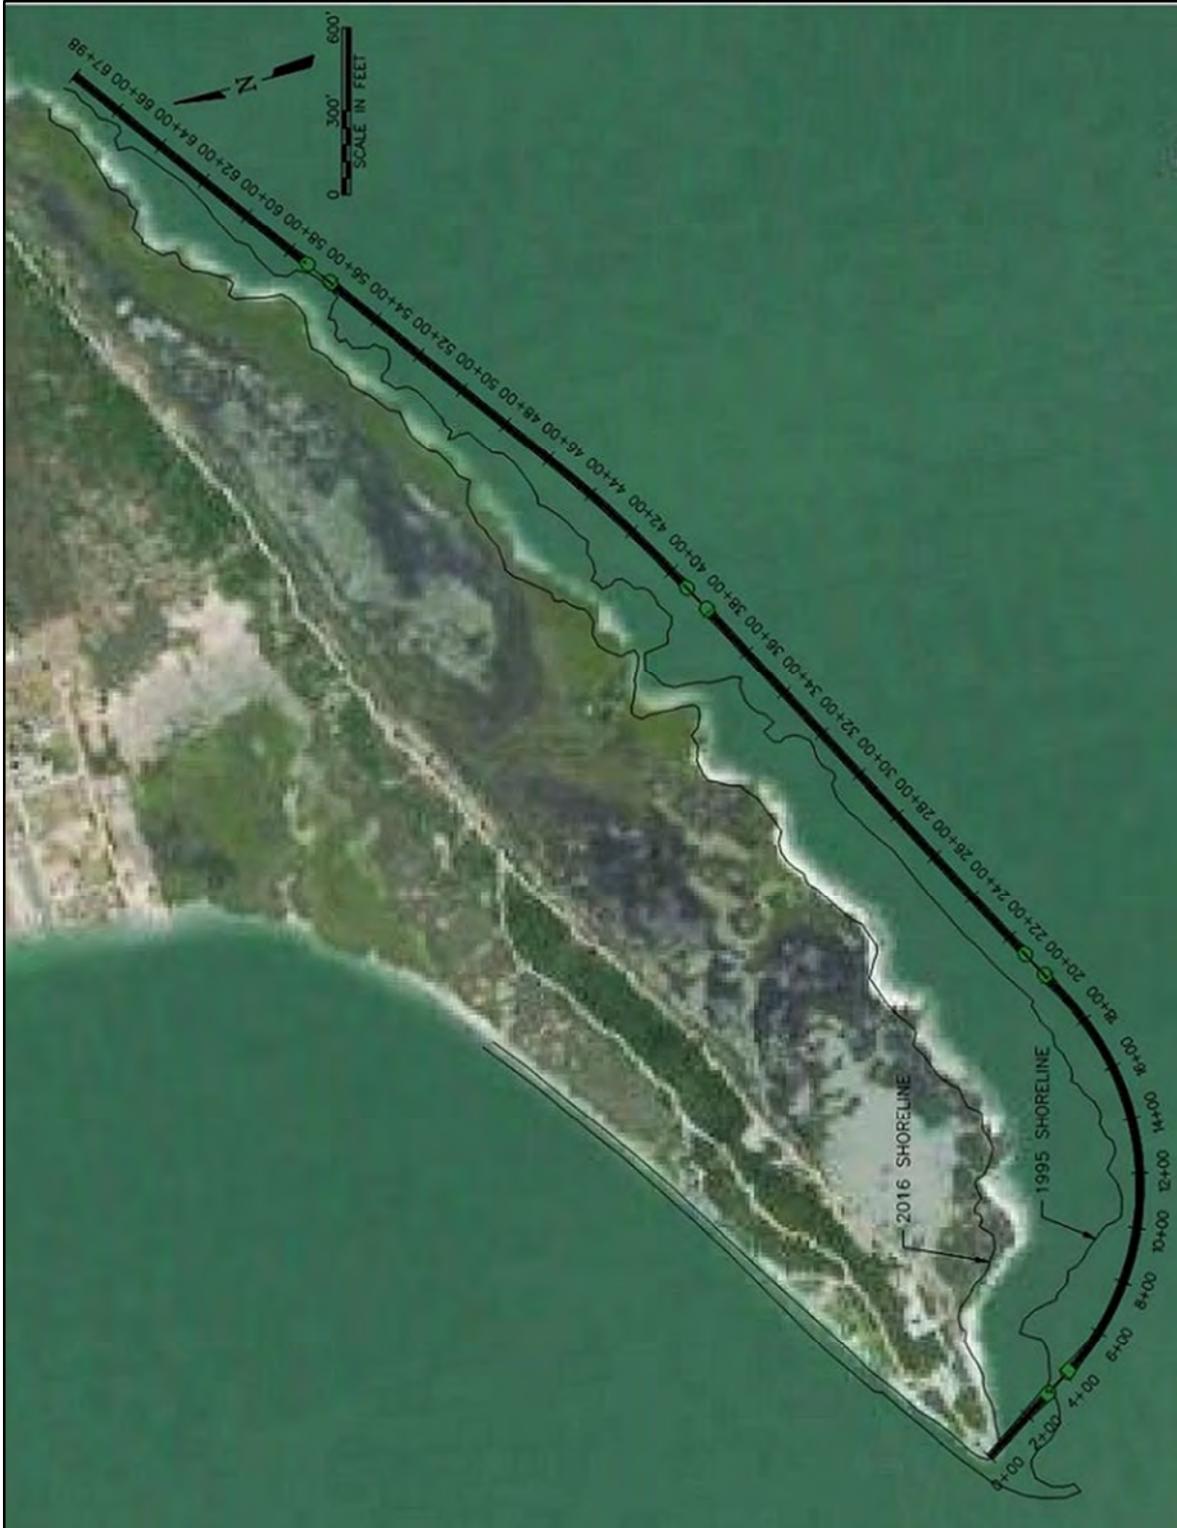
Figure 12. Plan view of 1.3-mile living shoreline. Living shoreline has been constructed from 0+00 to 35+75. The proposed project extends the living shoreline from 35+75 to 67+98.

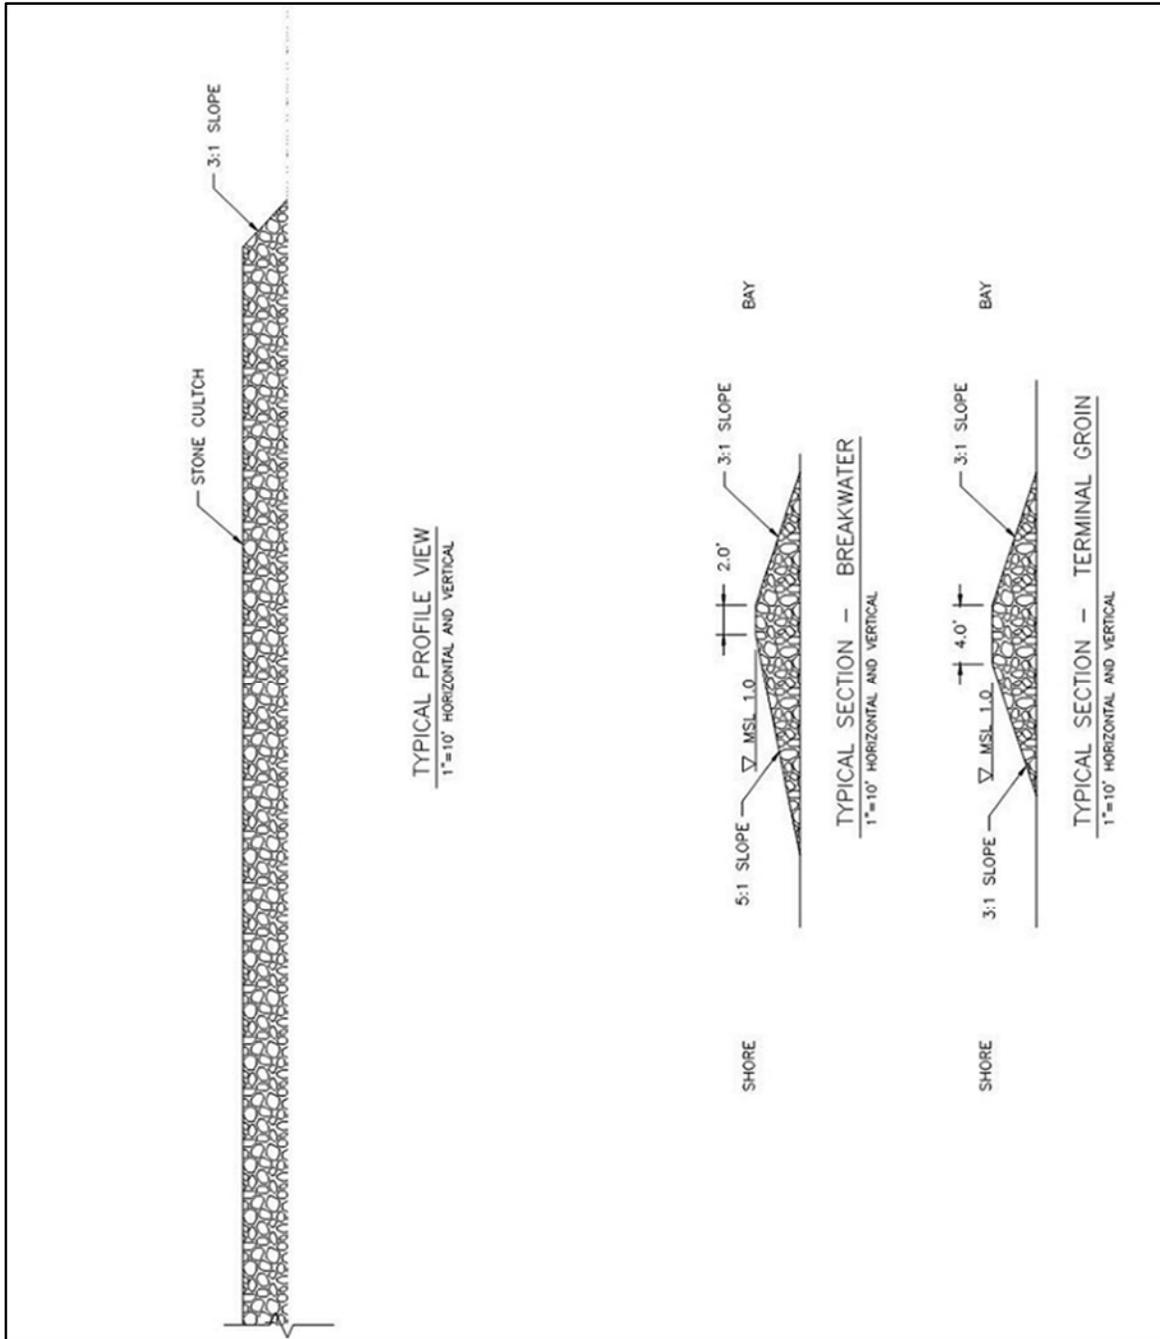
Figure 13. Cross-section views of 1.2-mile living shoreline including the proposed project.

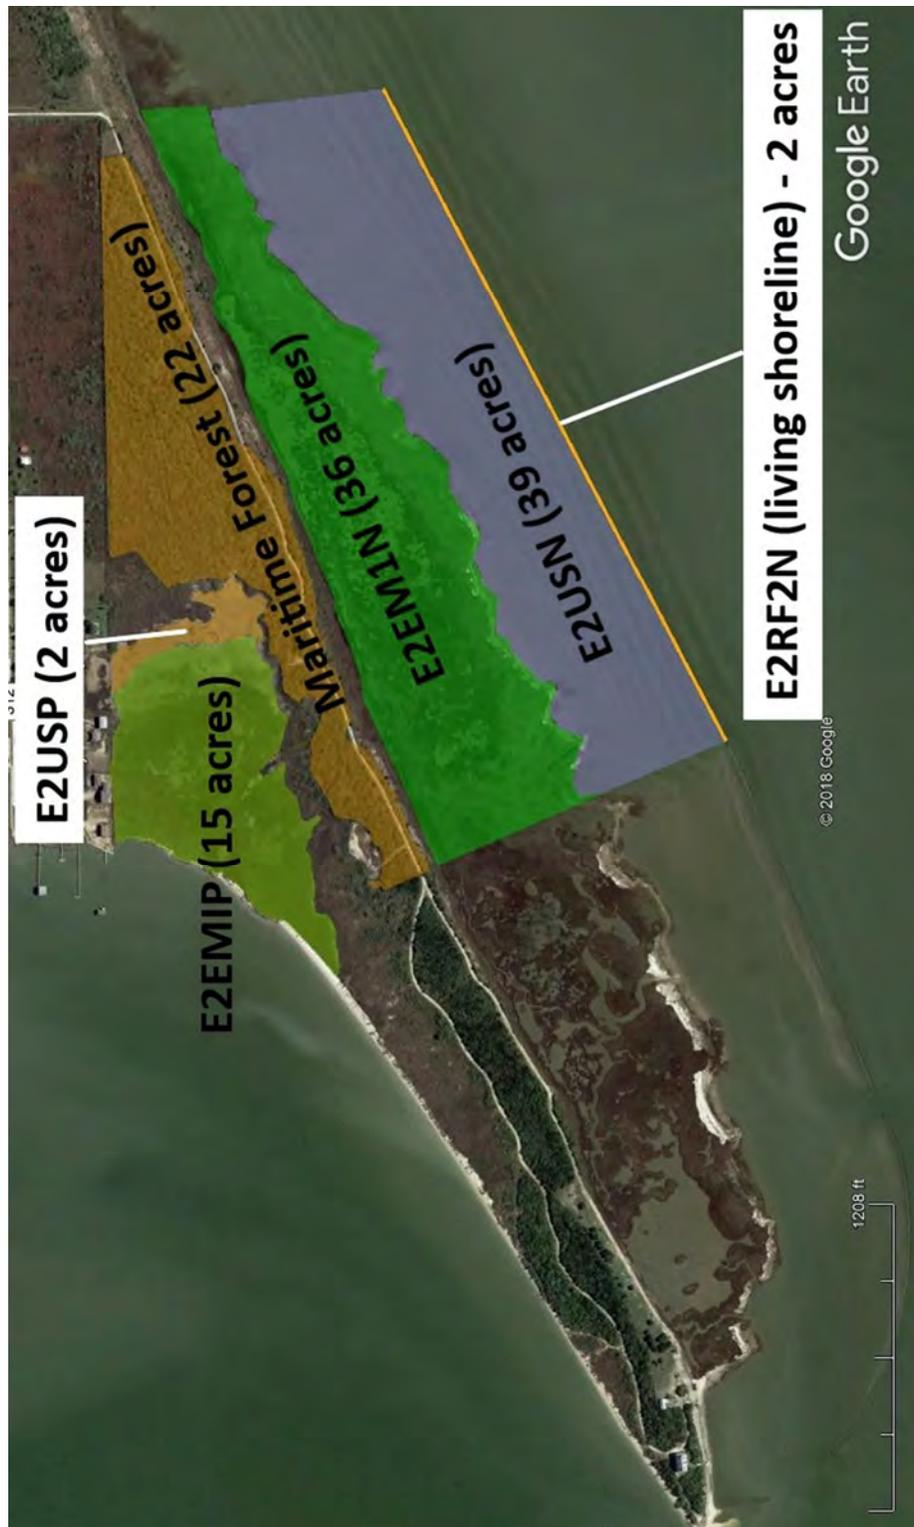
Figure 14. Wetland types and areas in project area (background photograph is from Google Earth, December 1, 2018).

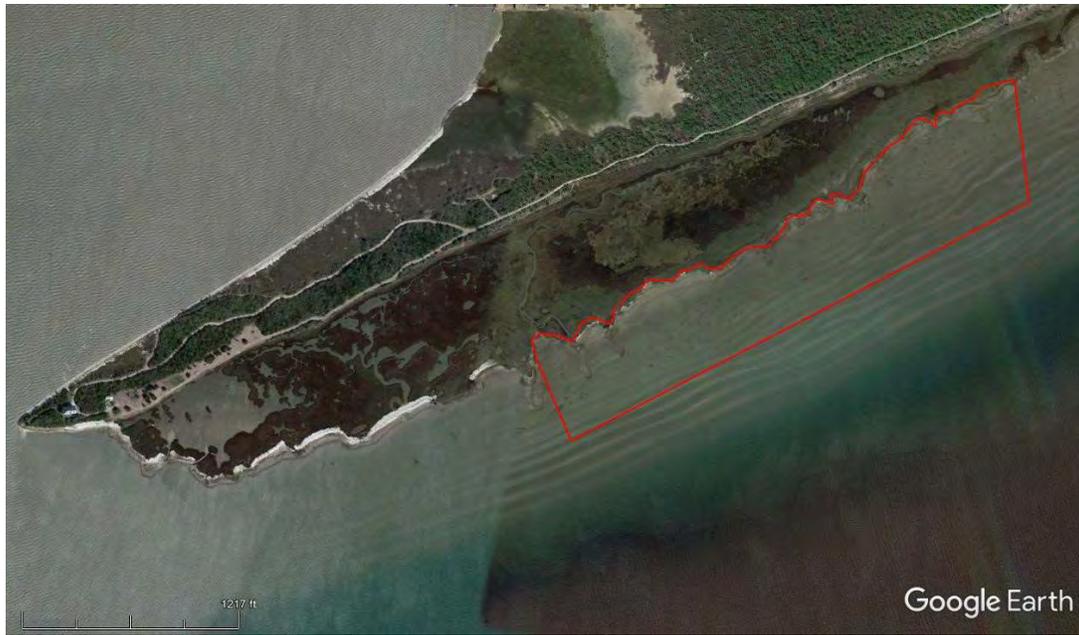
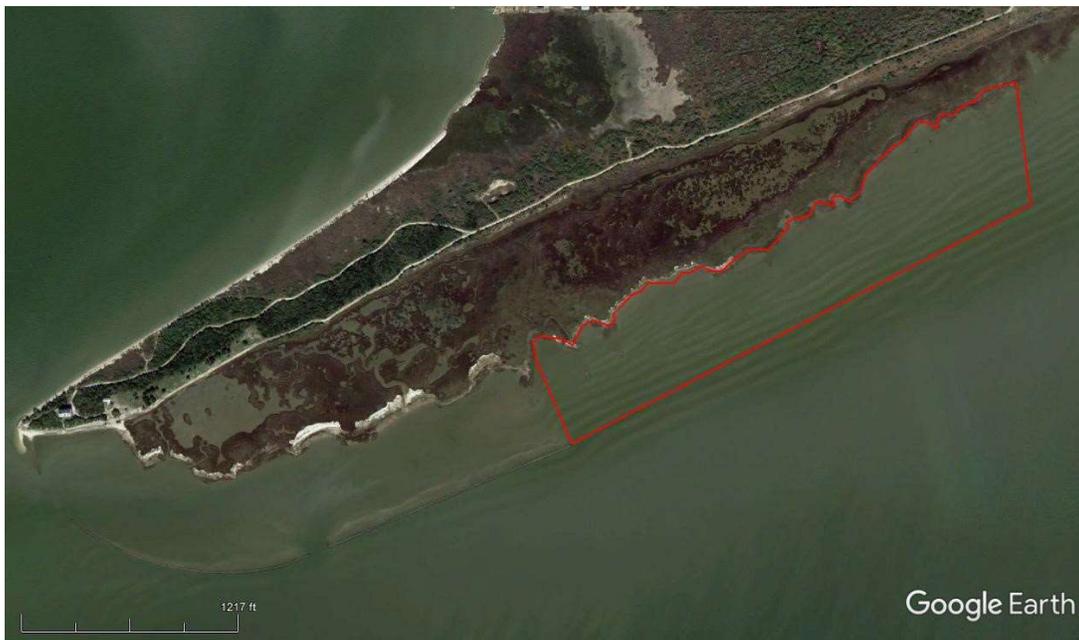
Figure 15. Photograph above is dated December 2, 2016, 18 months before completion of the living shoreline. Photograph below is dated December 1, 2018, about 6 months after completion of the living shoreline. Extensive areas of sediment accumulation can be seen behind the living shoreline along with increased plant coverage of shell hash berms. The area outlined in red is the Matagorda Bay shoreline to be protected by the proposed project.

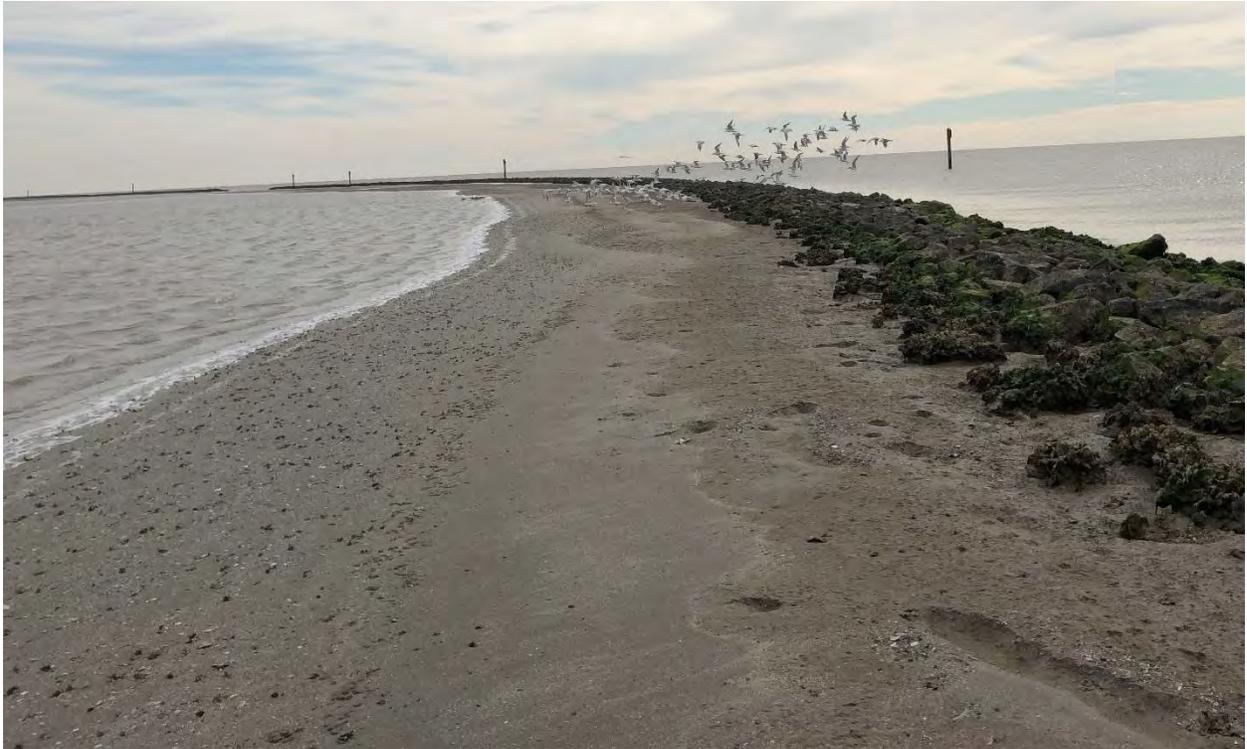
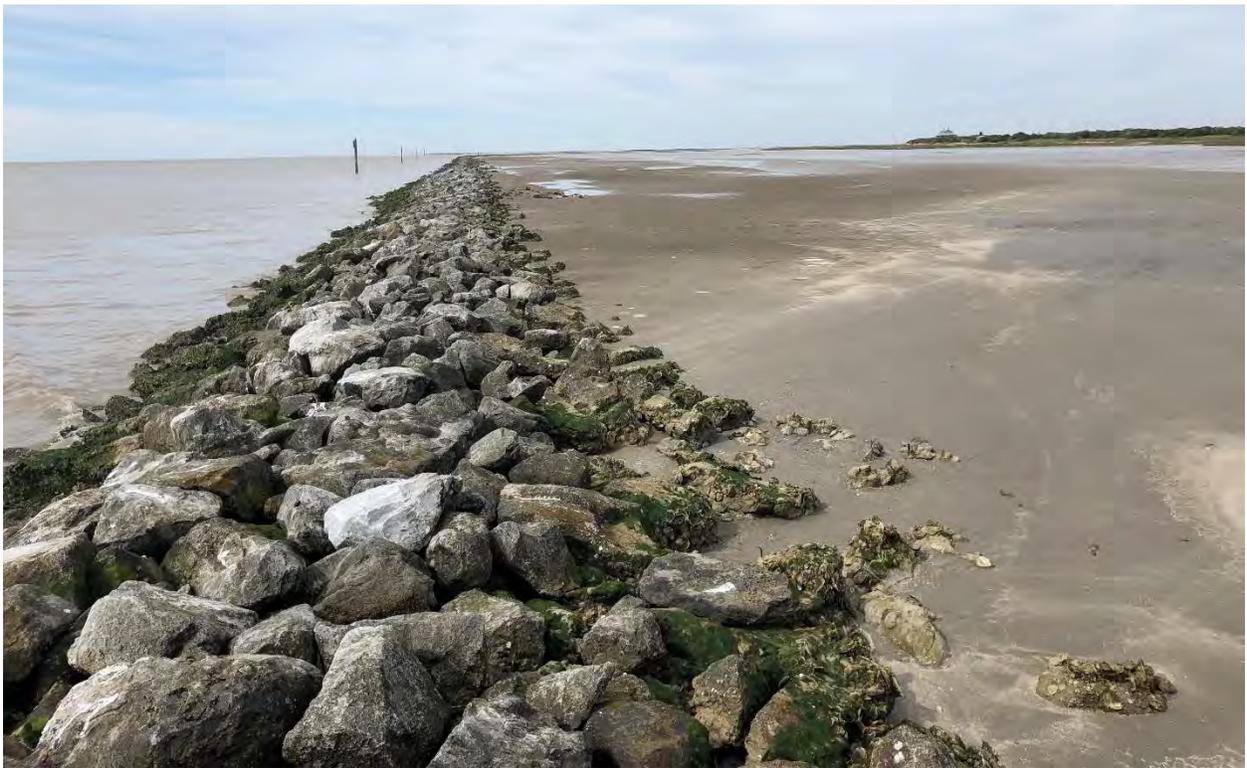
Figure 16. Sediment accumulation behind the Schicke Point living shoreline on March 5, 2019, 22 months post-construction.

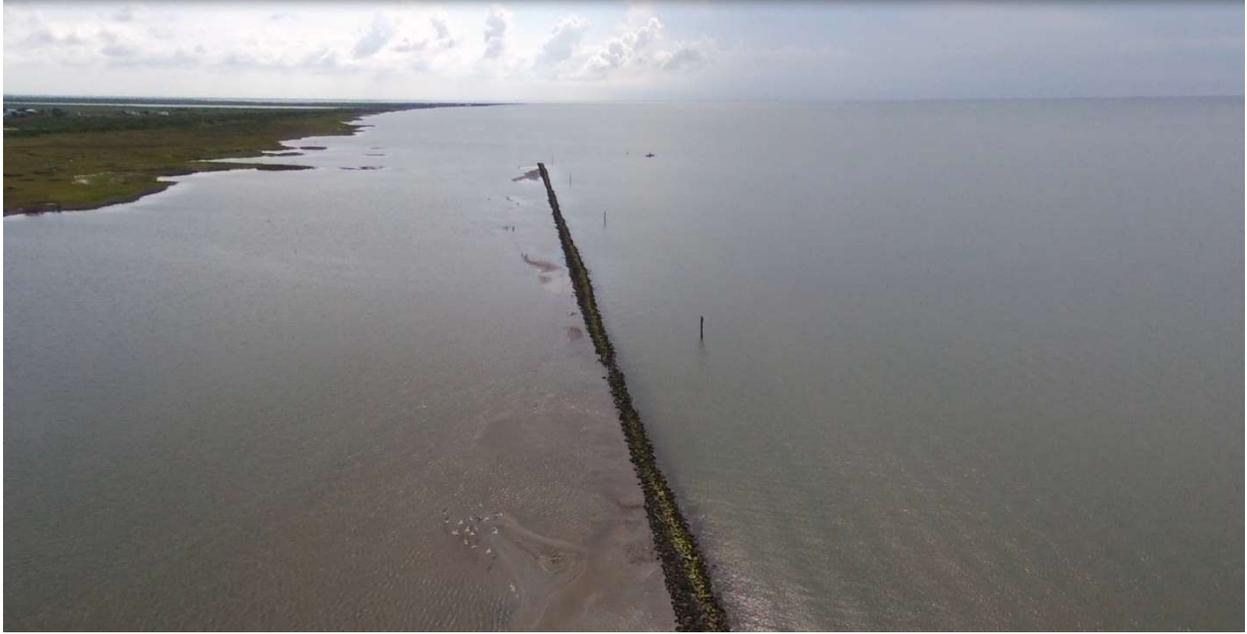
Figure 17. Sediment accumulated behind the Schicke Point living shoreline constructed in May 2017 (July 6, 2018, 14 months post-construction). Marsh in the background beyond the living shoreline is the marsh proposed for protection and restoration in this proposal.
