Schicke Point Living Shoreline

Response to Matagorda Bay Mitigation Trust
RFP# 2020-2021-1

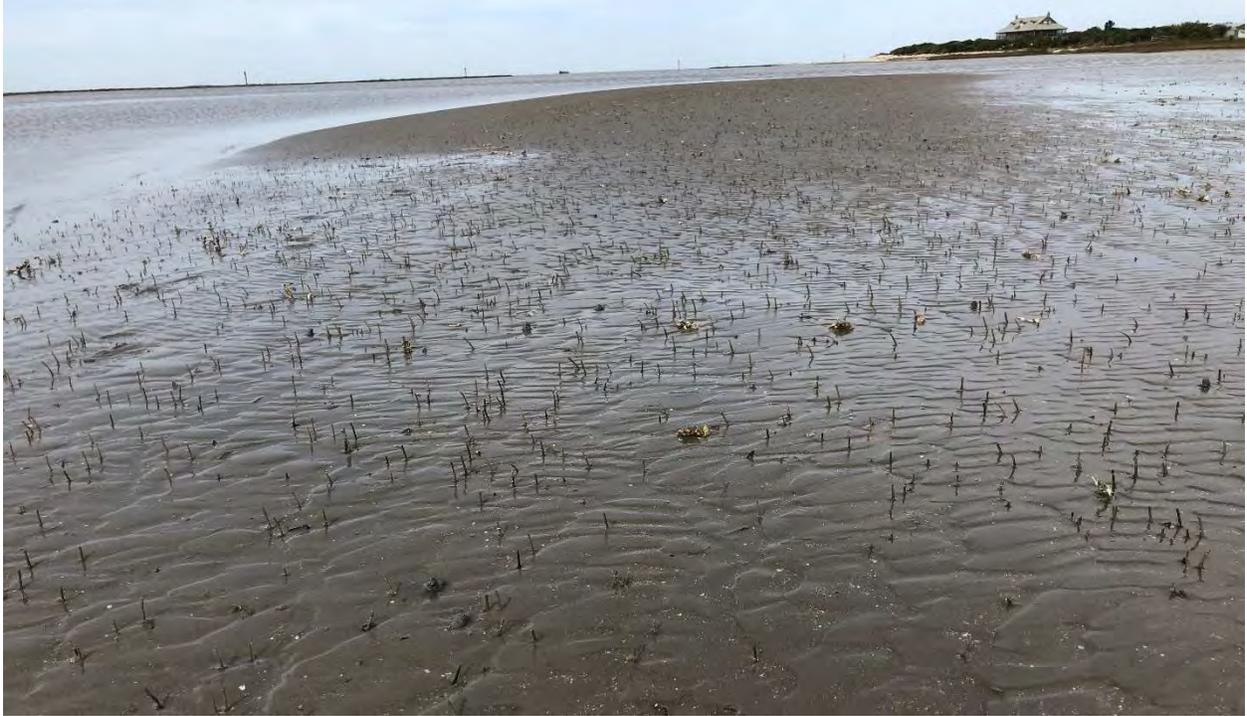
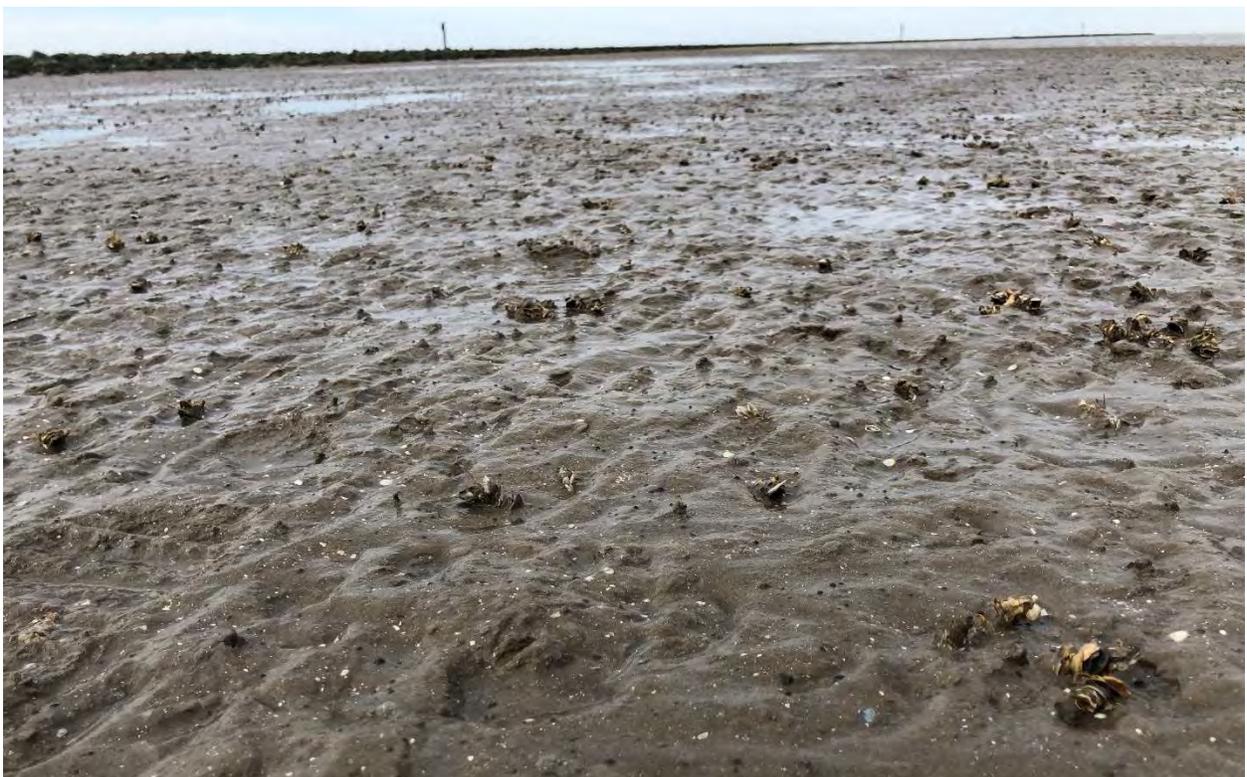
Figure 18. Polychaete communities populating sediment accumulated behind the Schicke Point living shoreline constructed in May 2017. Photographs taken March 5, 2019 during low tide.

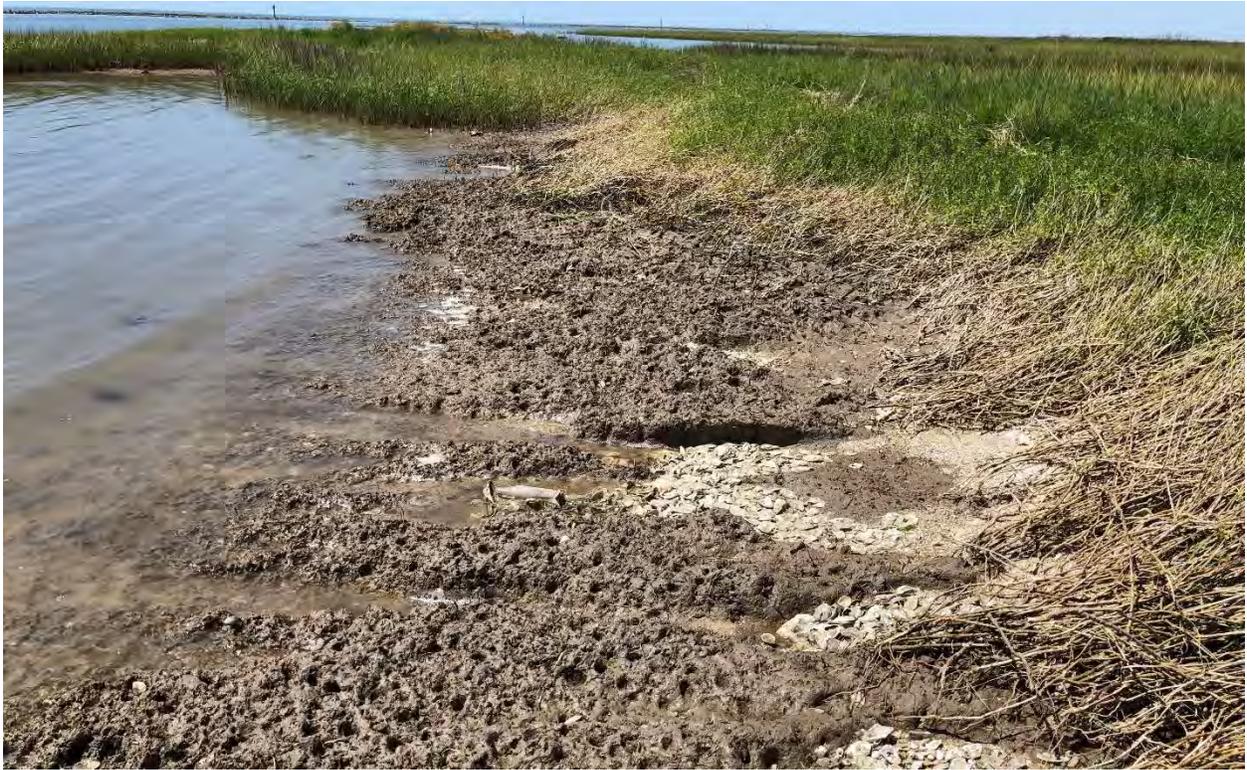
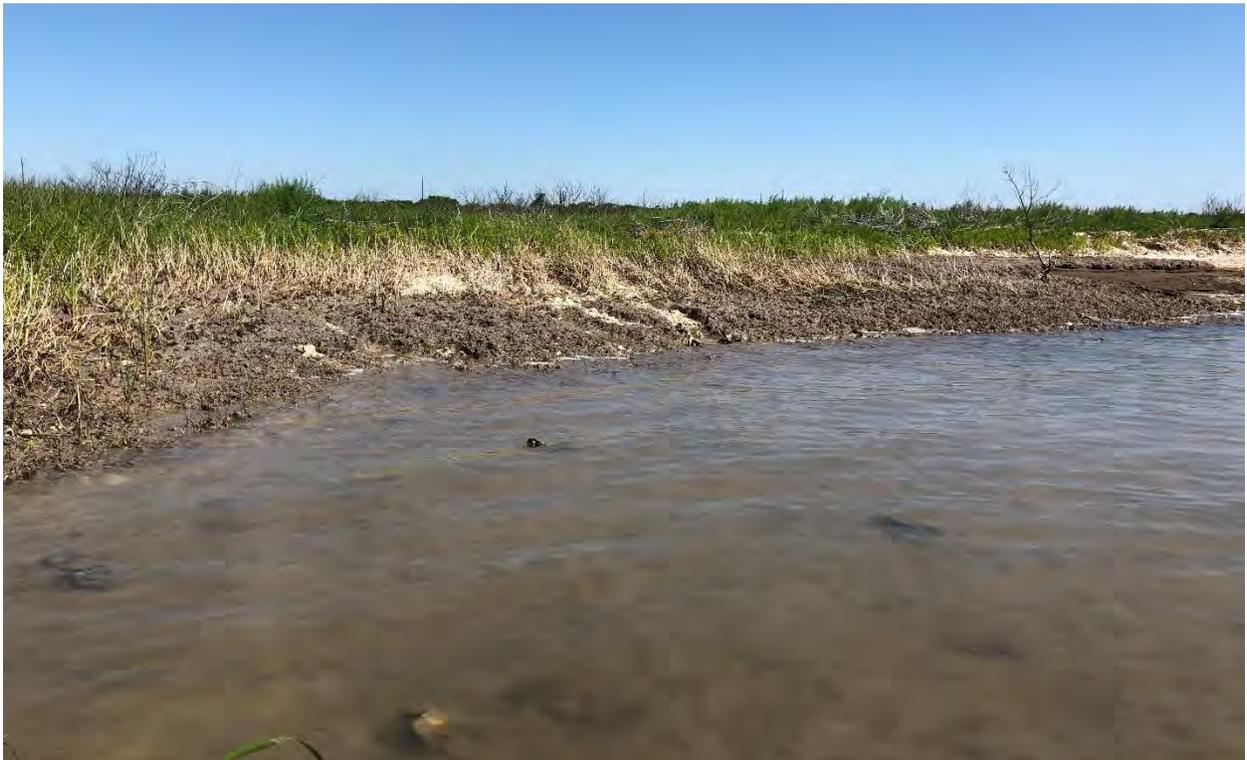
Figure 19. Marsh erosion along the Schicke Point shoreline to be protected by the proposed living shoreline (photographs taken April 29, 2019).

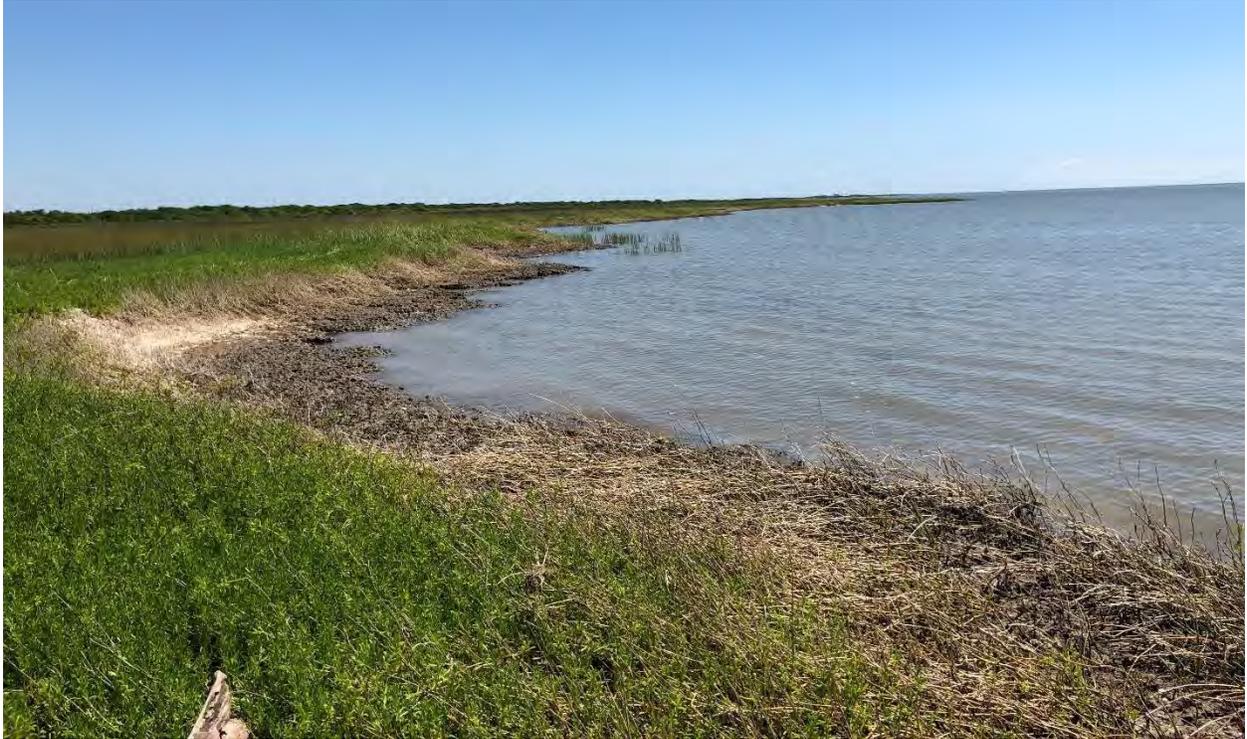
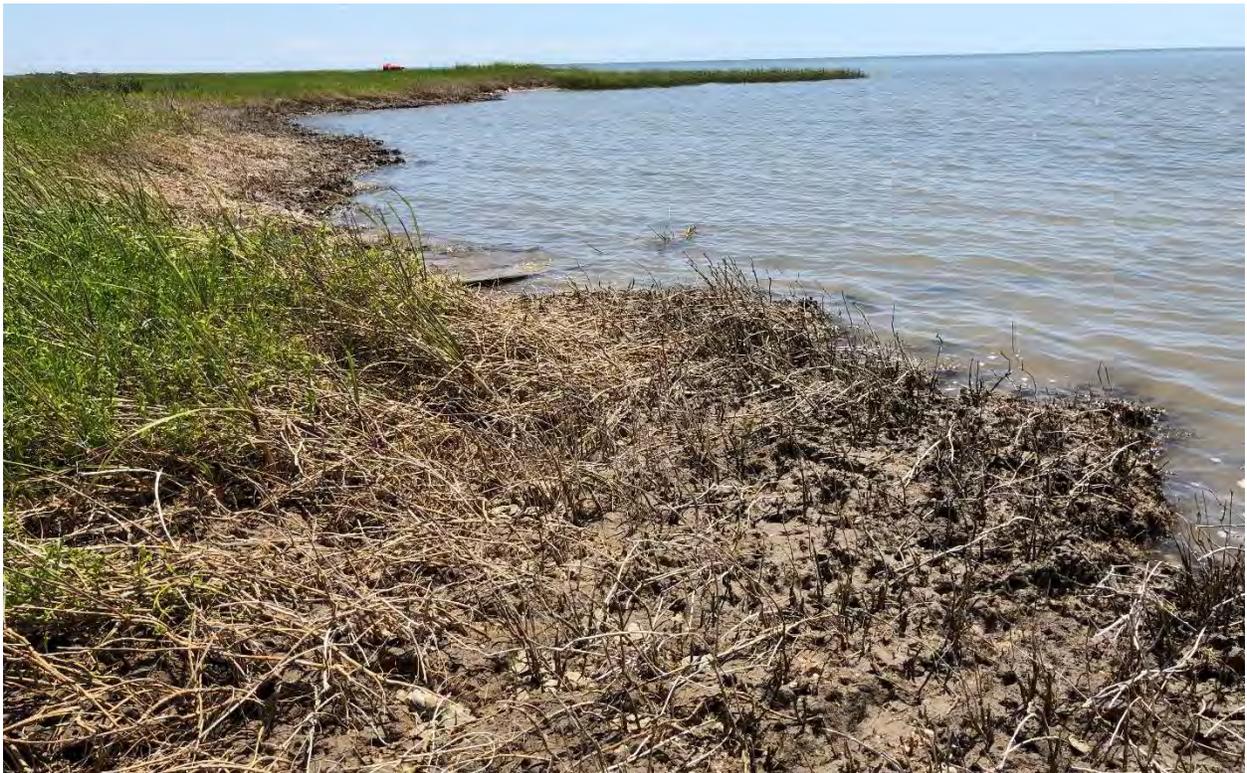
Figure 20. Marsh erosion along the Schicke Point shoreline to be protected by the proposed living shoreline (photographs taken April 29, 2019).

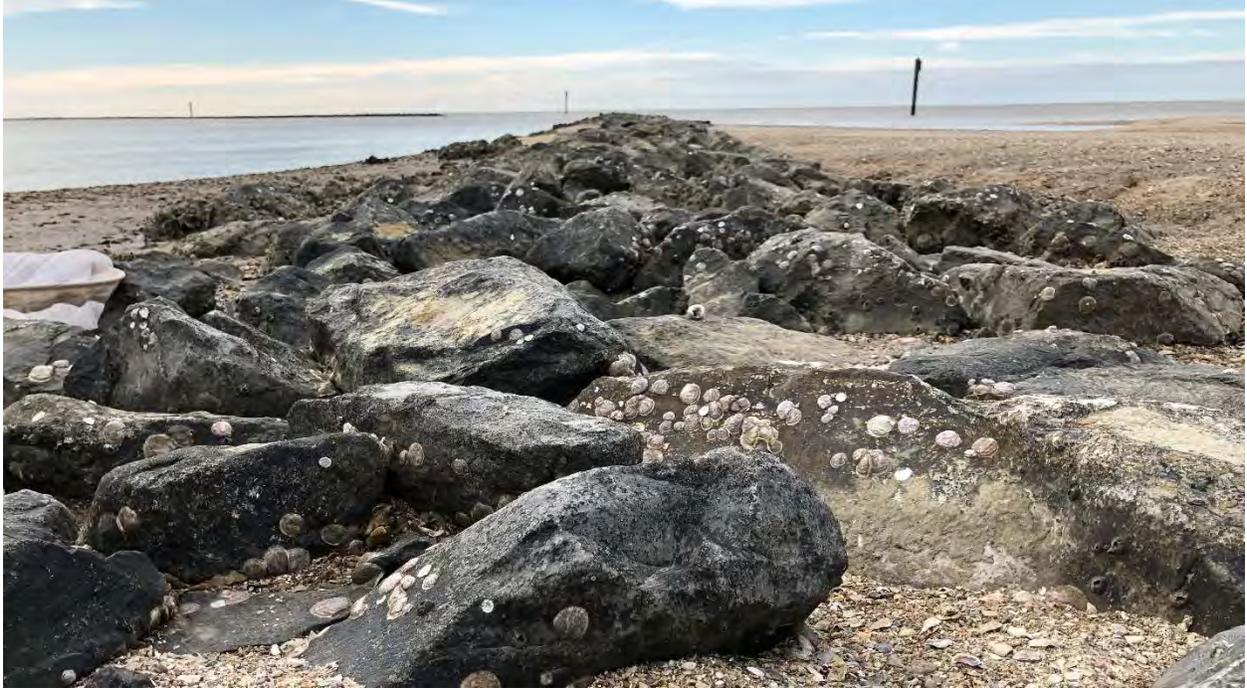
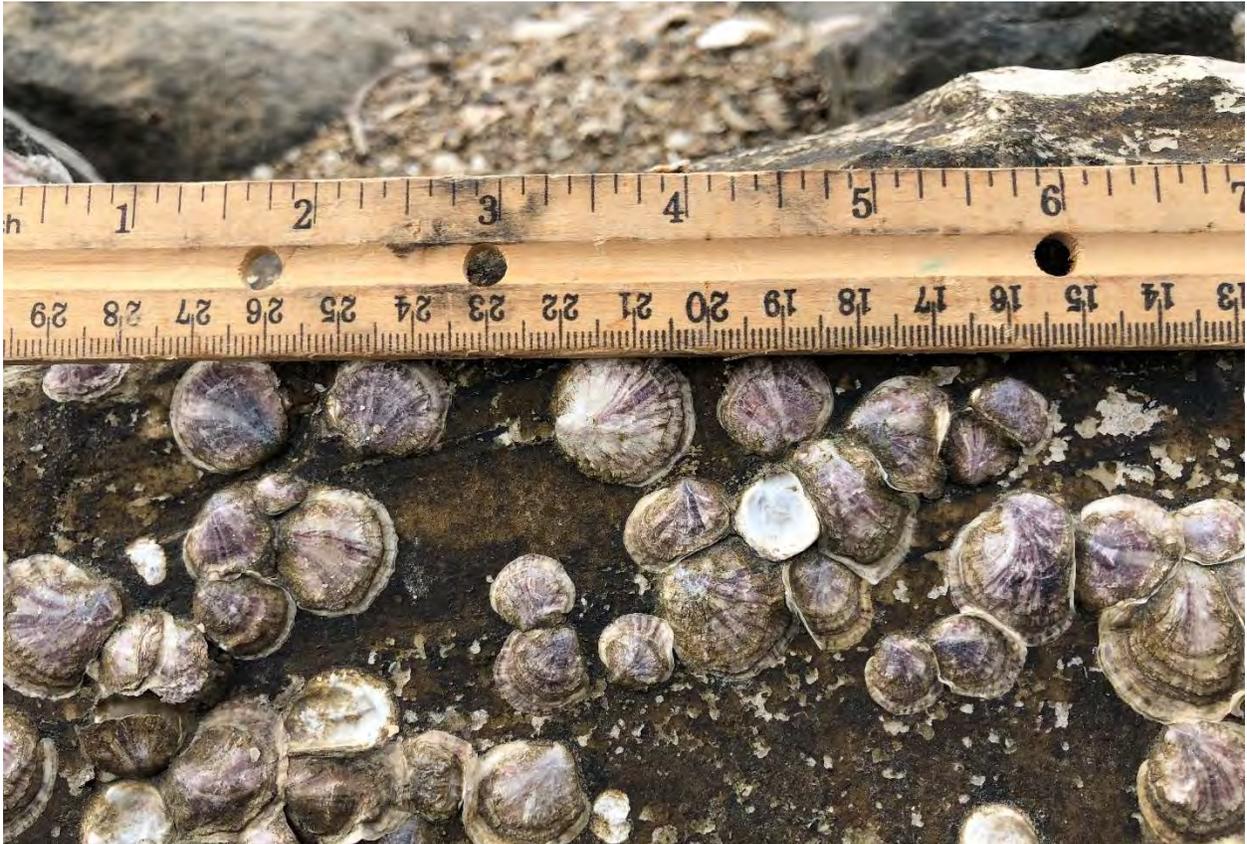
Figure 21. Oysters colonizing Schicke Point living shoreline constructed in 2017 (March 5, 2019).

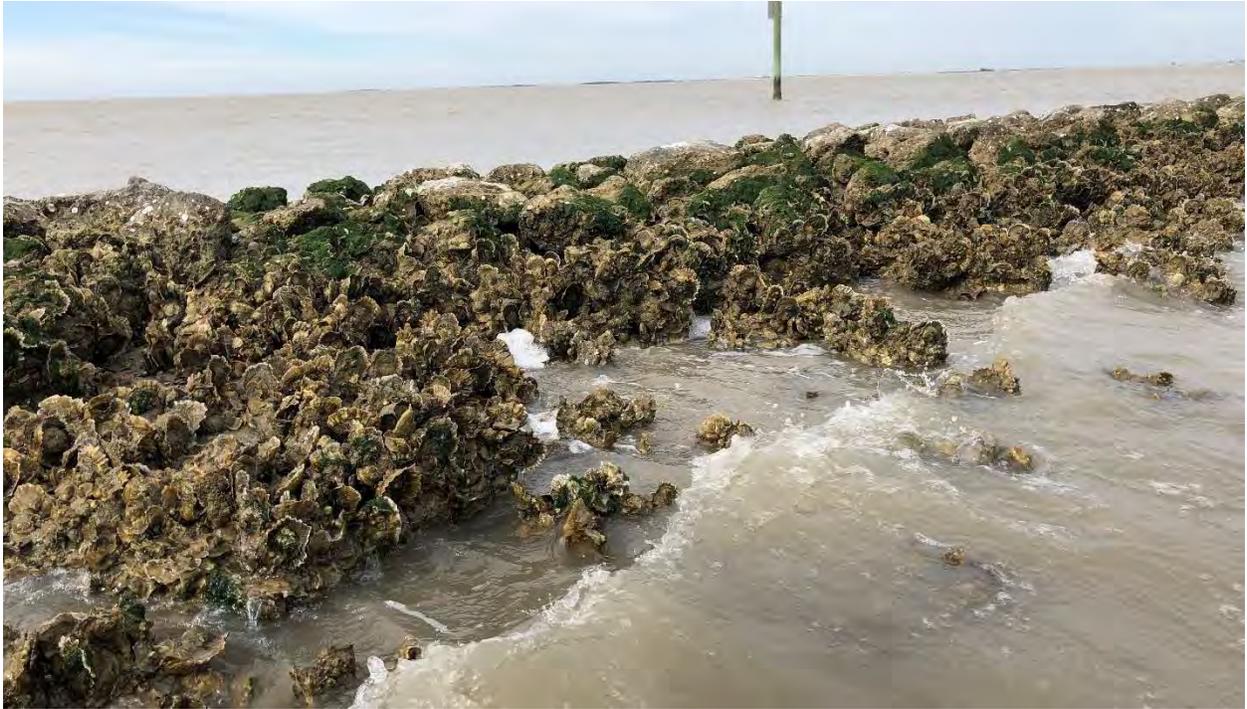
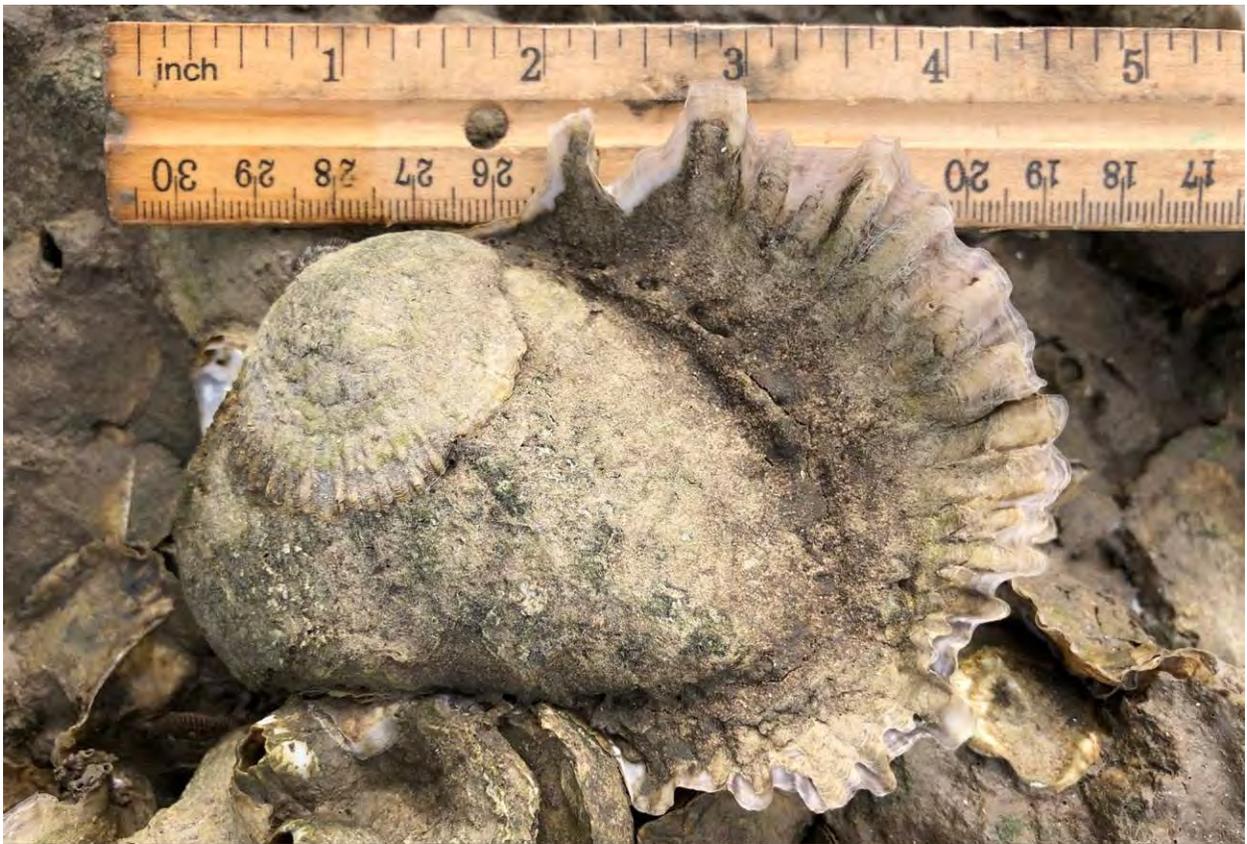
Figure 22. Oysters colonizing Schicke Point living shoreline constructed in 2017 (March 5, 2019).

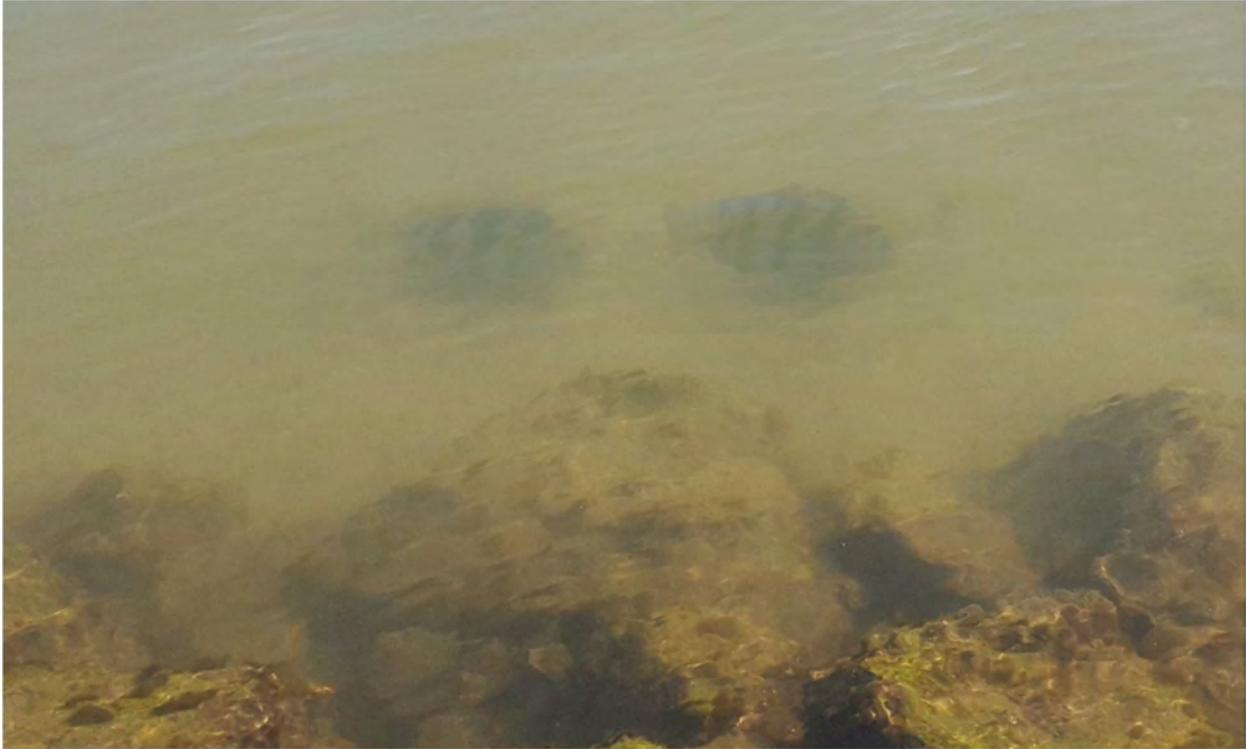
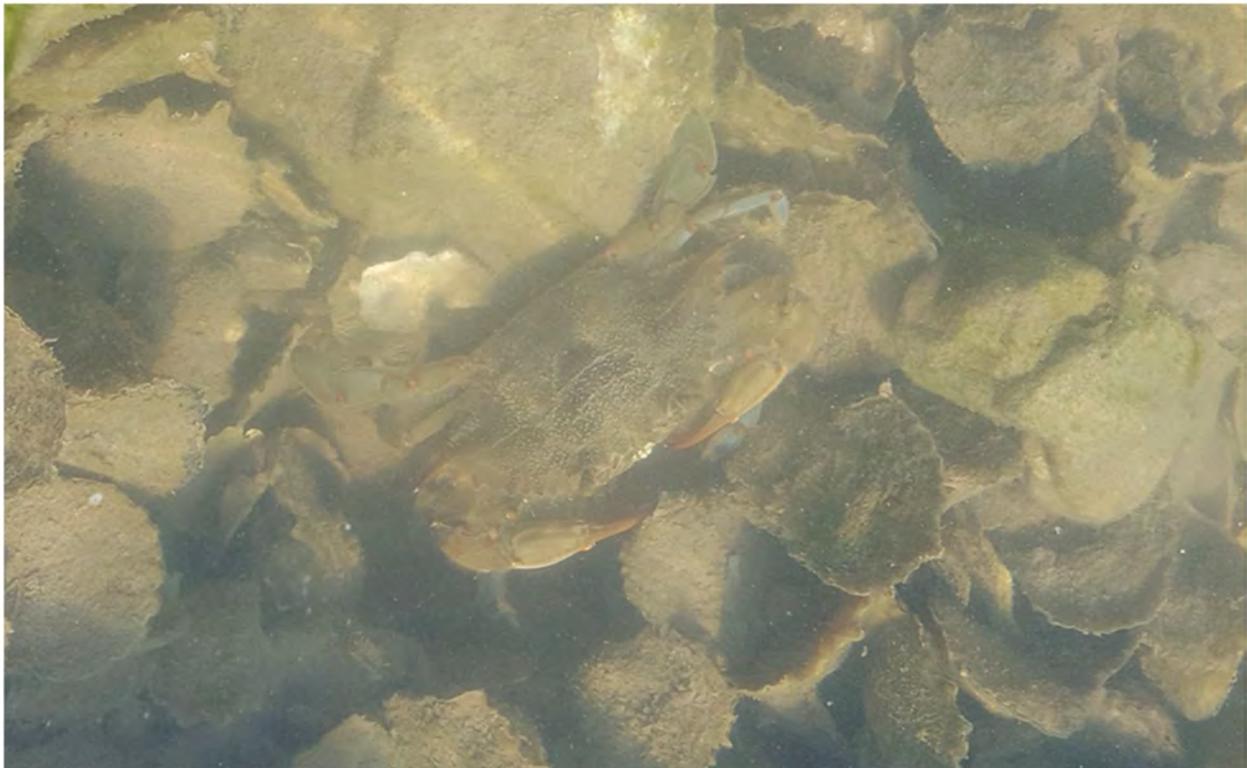
Figure 23. Photo above shows pair of Sheepshead along the bay side of the living shoreline and the photograph below shows a blue crab among oysters on top of the living shoreline.

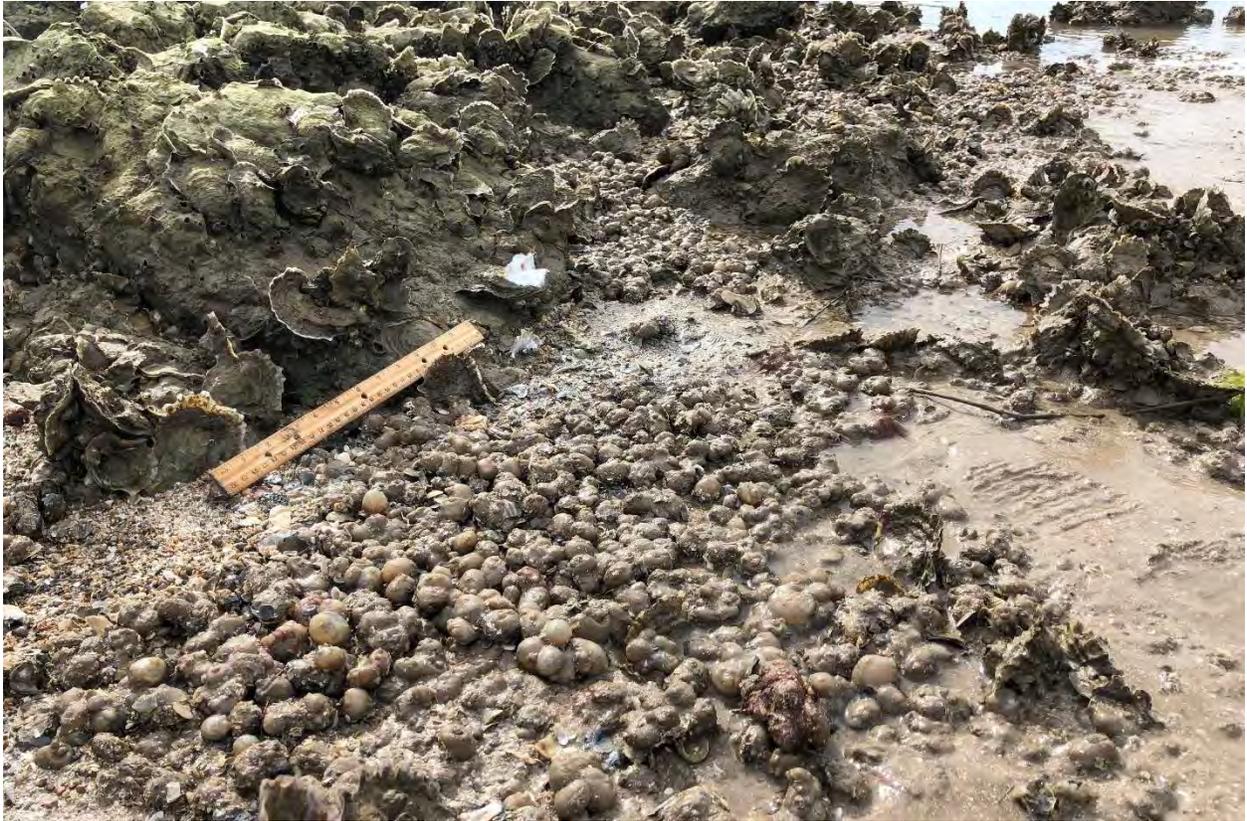
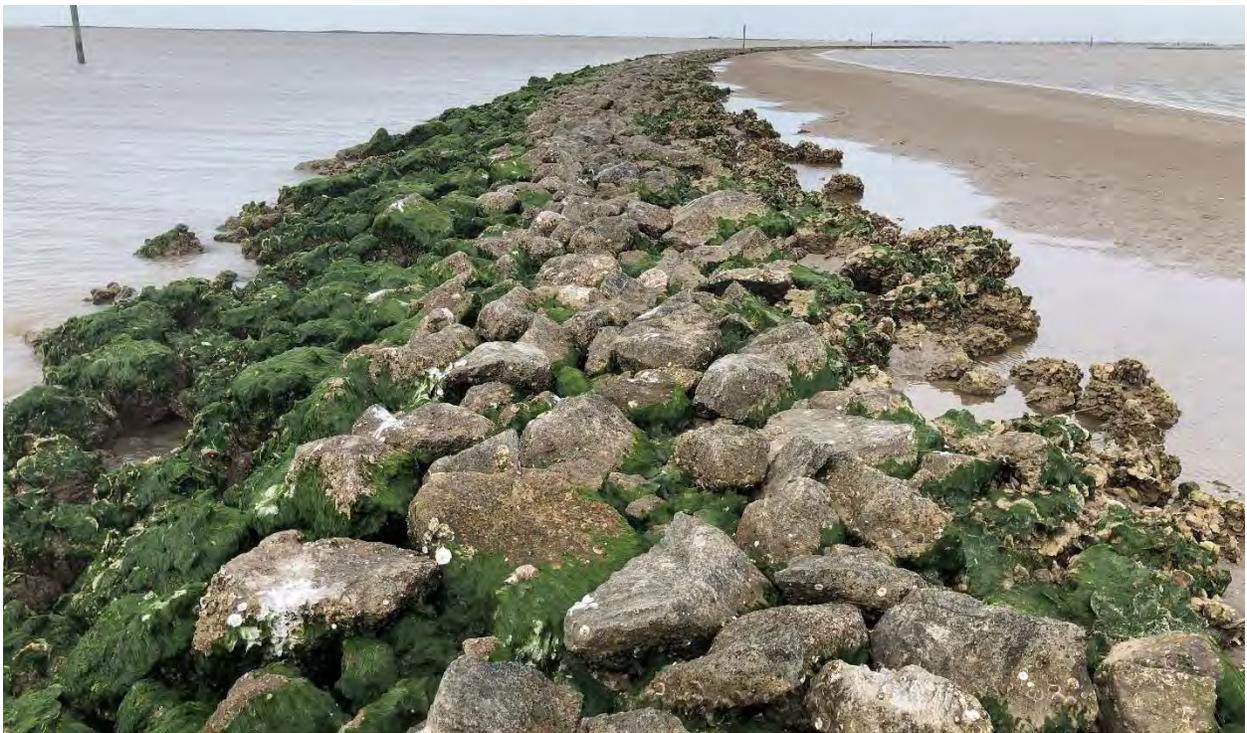
Figure 24. Algae, oysters and tunicates growing on living shoreline at Schicke Point created in May 2017 (photographs taken March 5, 2019).
