Activity report on the project “Microplastic concentration in sediments and waters of Matagorda and San Antonio Bays: Initial assessment and mitigation plans”

Period: January 1st 2024 to March 31st 2024 – Continuation of laboratory microplastics separation and description of filtered material, analyzing the data collected on Colorado Delta.

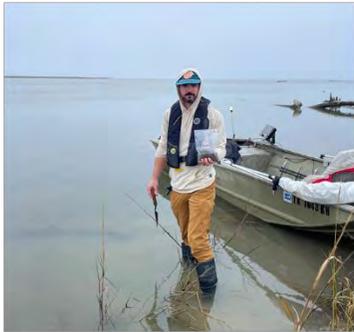
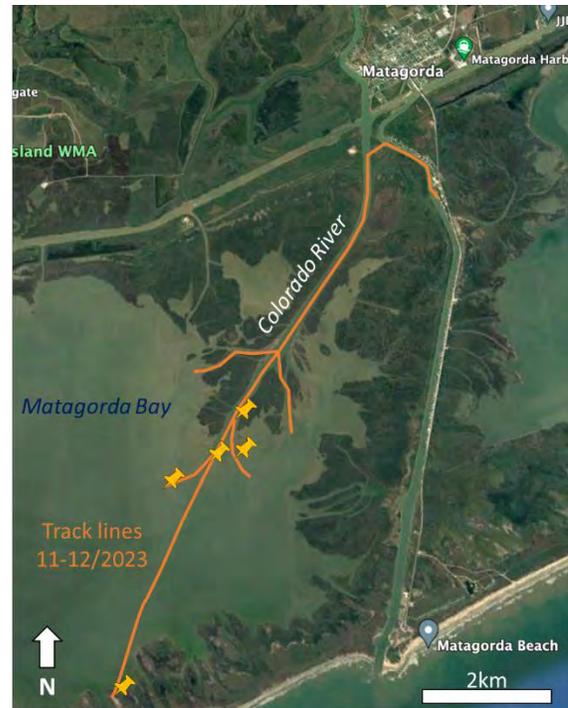
Figure 1. Data collected during December 2023 field work. Lower left photo show sediment data collected in delta front area of Colorado. On the right the lines of Chirp data and sediment sample locations.

Field campaign in the area of the Colorado River Delta, in the eastern part of the Matagorda Bay have been undertaken. During the week-long field work we collected sidescan, & CHIRP data to better understand the bathymetry and sedimentation in the Colorado Delta, and also got sediment grab samples to analyze for microplastic content of the river derived sediments that are accumulating in the bay (**Figures 1-2**). The scope of the data collection is to better understand the sediment and microplastics dispersal from the Colorado River into the Matagorda Bay. Microplastic analyses for these new samples is still ongoing.

- **Aim:** understand recent delta composition & morphology
- **Collected:** grab samples, sidescan, & CHIRP data
- **Test:** whether primary bay sink links with plastic concentration
