## TECHNICAL MEMORANDUM

TO: Bill Balboa, Executive Director, Matagorda Bay Foundation

FROM: Matthew Chastain, Sabrina Thiels, Mike Page  
Compass Environmental Solutions, LLC

SUBJECT: **Benthic Habitat Mapping Technical Memorandum and Deliverables**

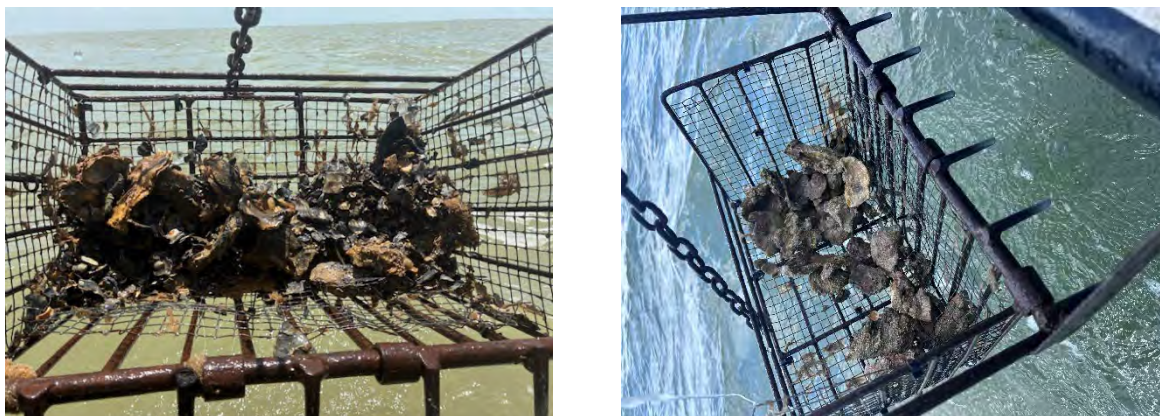
The collected contents were photo-documented (pre- and post-rinse) and described. Live oysters, oyster shell, shell hash, and reef material were noted to determine potential presence or absence of oyster reefs and suitable substrate. Also, any additional finds were noted including but not limited to rangia shells, barnacles, hook mussels, and worms.

**Figure 5.** Custom oyster dredge (left) and collected materials being rinsed (right).

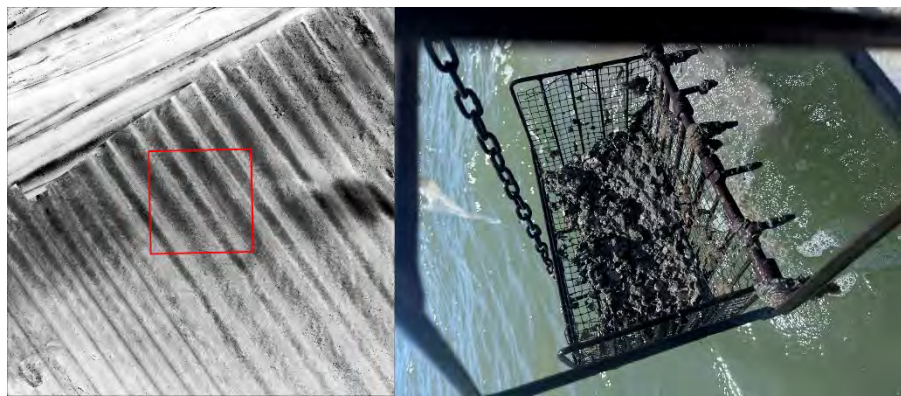
**Category 3: Interspersed Firm Mud and Sand**  
(Reference Sample Site 46)

During the last century, a host of projects and anthropogenic influences have shaped and altered the substrate and bay bottom of various portions of Matagorda Bay. These projects have included the historical Intracoastal Waterway (prior to its current alignment), and multiple dredged ship and barge channels to access both Matagorda Island and shallower portions of Matagorda Bay. During these events, dredged spoil material was generally side-cast, resulting changes to the natural bay bottom habitats and a range of material classifications, including firm and soft muds and a general lack of large sandy areas. Additionally, buried and/or black shell and other similarly stained substrate was observed in this category. This category would potentially represent low to moderate success probability for oyster reef restoration and creation activities, and would need to be analyzed further for suitability.

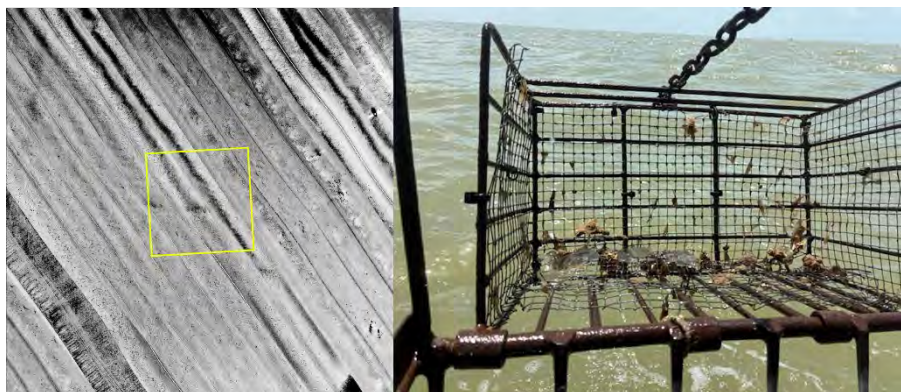
**Category 4: Open Bay Bottom**  
(Reference Sample Site 4)

Devoid of oysters, viable habitat, or potentially favorable materials for reef establishment, the majority of Matagorda Bay was classified as Category 4. While dredge tows, sampling efforts, and sonar analysis in this category revealed no oysters or suitable substrate, it did reveal the presence of various other bay features including underwater sand waves and ripples in the southern portion of the survey area, open bay flats and seagrass beds along the central portion, and unconsolidated silts/clays, especially around the Diversion Cut and near the lower Colorado River delta in the northeast. This category would potentially represent lowest probability of success for oyster reef restoration and creation activities.
